RECORD OF TREATMENT

MASSACHUSETTS BAY COLONY TERCENTARY MARKERS

RECORD OF CONSERVATION TREATMENT

Objects: (11) Tercentenary Markers

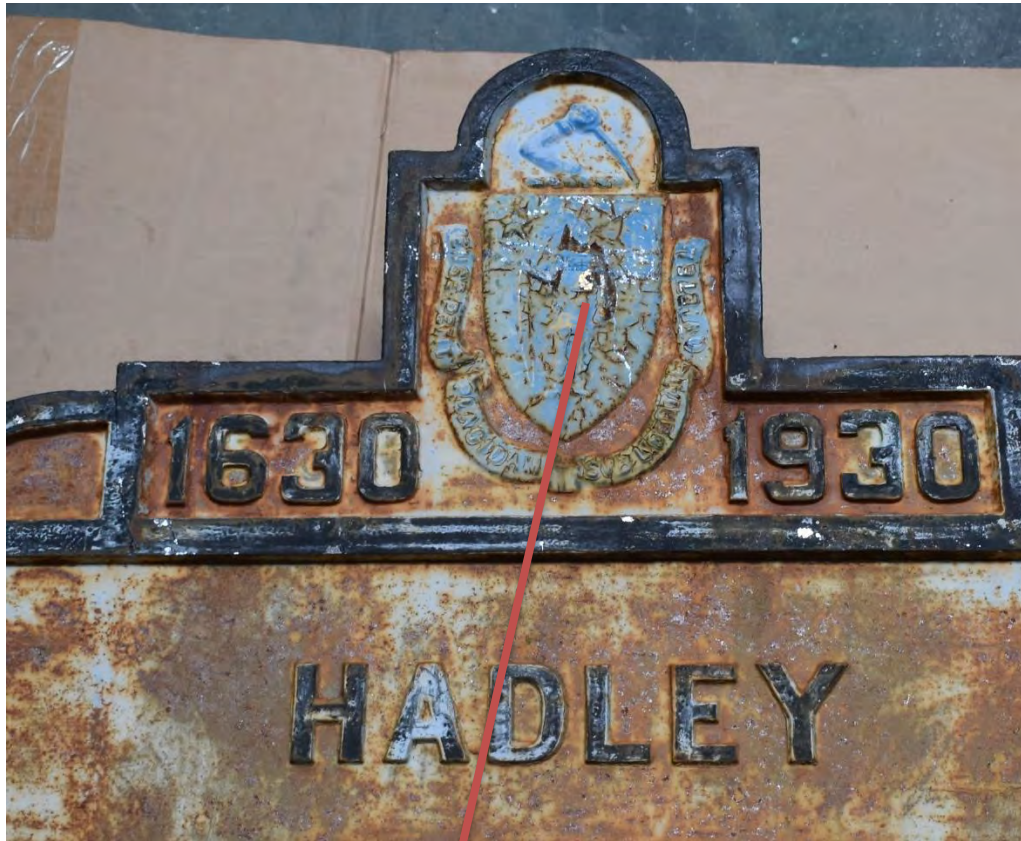
We did find a few spots of what appeared to be original gold leaf on the Hadley #1 Marker .

This appears to be
gold-leaf on the
surface below
layers of over-paint

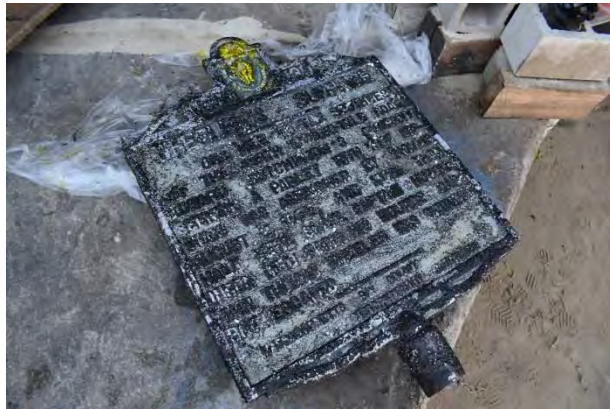
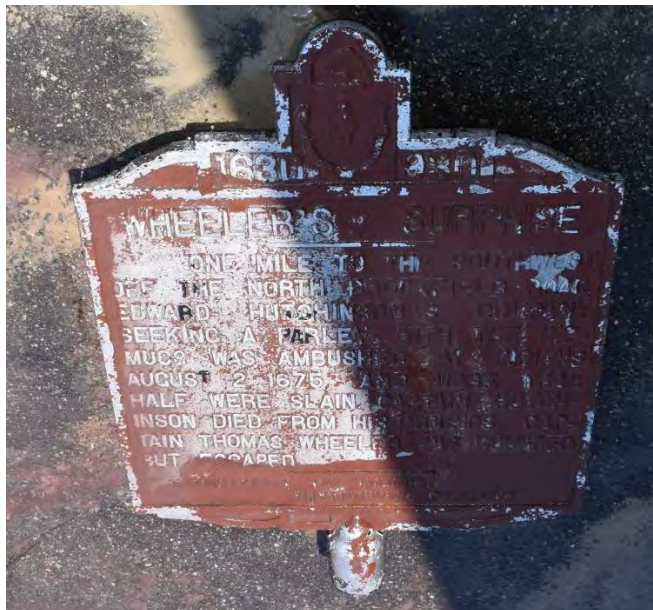
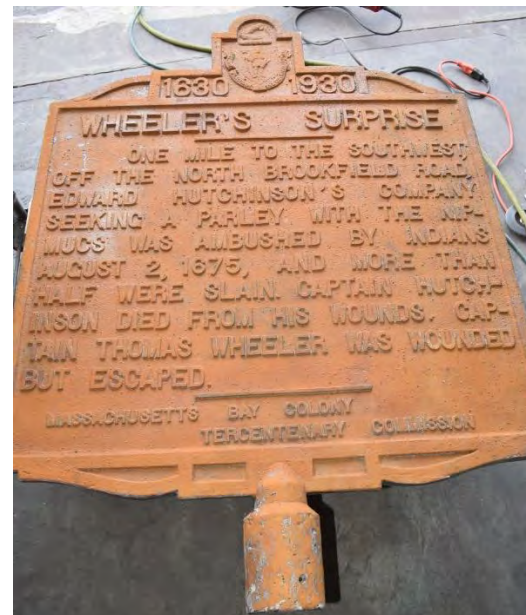
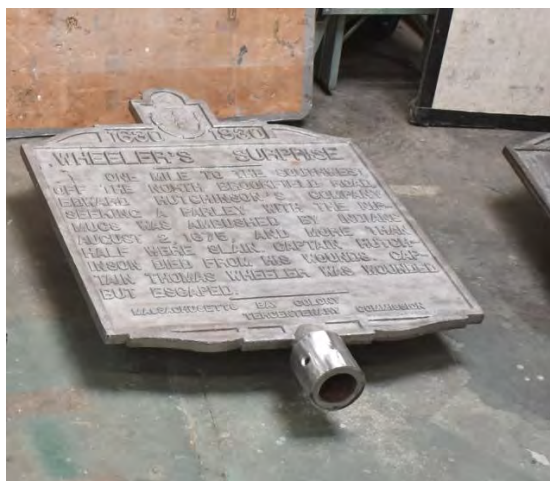
Stages of pain and rust
removal: Wheelers Surprise

Once the majority of the of the paint was removed and we were able to clearly identify the original surface, the markers were cleaned of rust, and paint stuck in the interstices by blasting the surface with glass beads (AD 70-140 beads using a Nederman SB 750 dustless suction blaster) and mechanical with hand pads and Norton Rapid Blend nx wheels as needed.

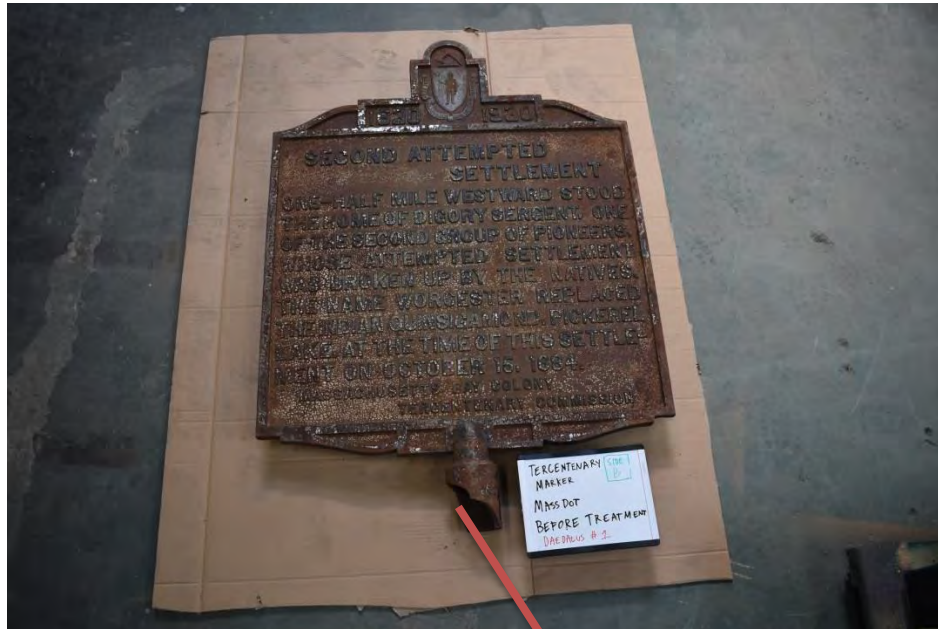
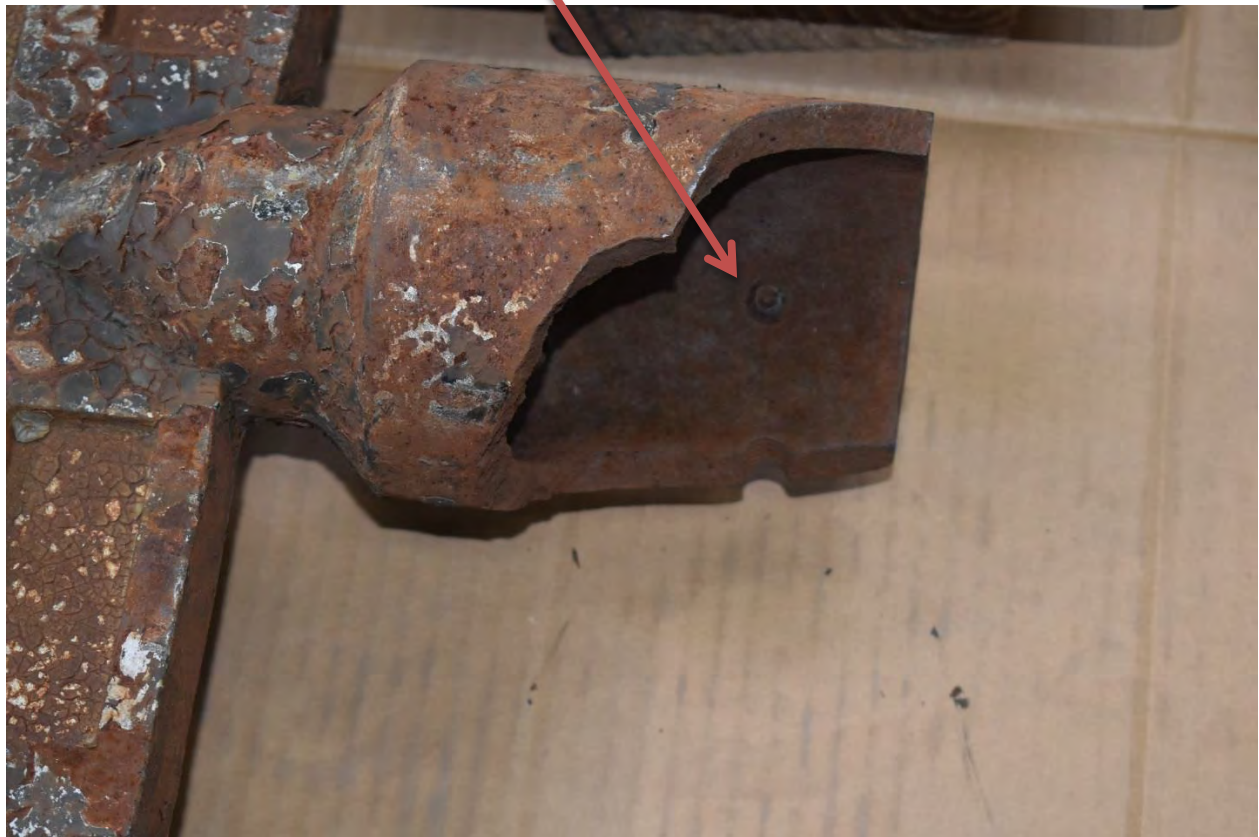
Detail: Broken Collar

We observed small cracks on every one of the collars (the cylindrical section of the marker which attaches to the post). In four of the eleven markers, the cracks resulted in u-shaped losses. Eight of the eleven original posts were either missing or had structural issues which warranted replacement. These observed signs of degradation and failure can likely be attributed a combination of factors including: material choice, design of the connection systems and environmental conditions.

The method of fastening the collars to the post was inconstant in size, quantity and locations of the bolts; the cracks seem to emanate from the bolt holes and also on the bottom edge of the collars.

First, the gap between the collar and post-tube was an access point for water infiltration --resulting in rust expansion on the collars, tubes and fasteners. This expansion force could theoretically both create small cracks and turn small cracks in large losses (*Toughness is defined as the ability of metal to resist fracturing and further failure under stress*)

The second issue is that collars don't feel robust (thick) enough to support the weight of the markers (as they absorb the wind, snow, rain, shifting of ground, vibration from traffic) or have enough material to create a solid connection for the hardware to fasten. Again this condition could have led to cracks in the collars and failure in the connection between the markers and post.

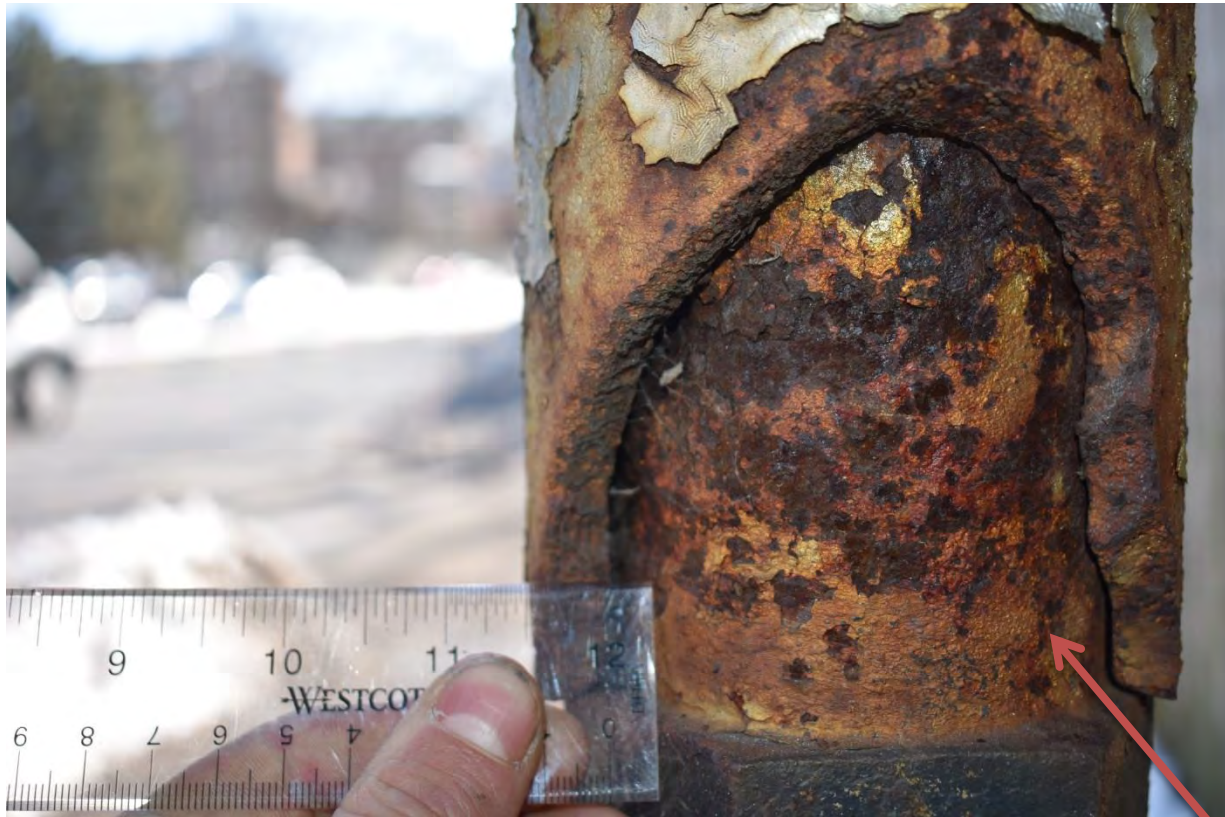
Connection between
Collar and Post (U-
shaped break on
collar)

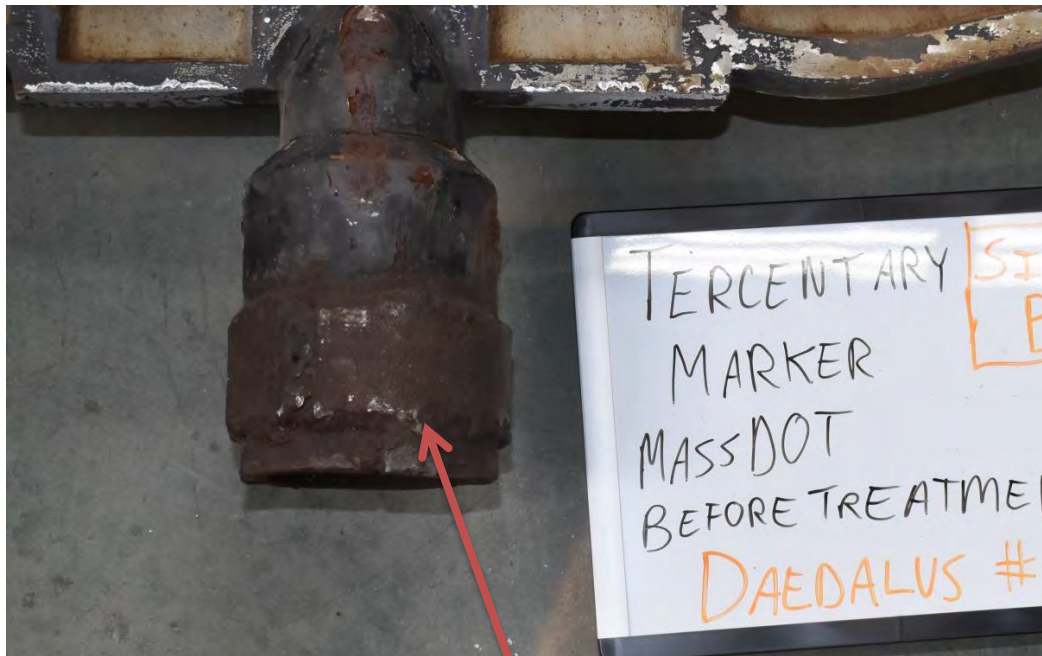
These factors could have ultimately led to local communities repairing the markers on their own which would explain many of the inconsistencies we observed in the attachment systems. Many times the well intentioned "fixes" led to more damage and in some case these repairs they were not in-line with the visual intent of the designers

Previous Repair to collar using a welded steel ring

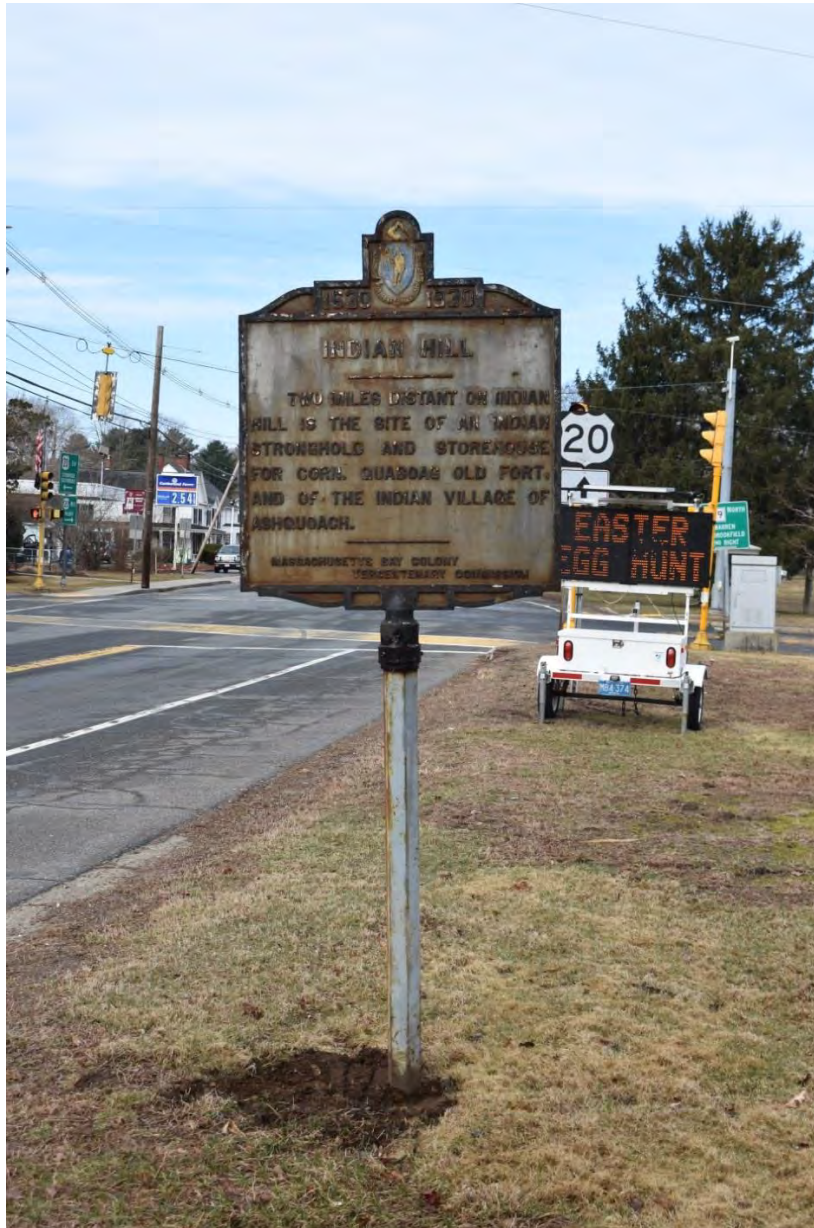
BEFORE
TREATMENT

Collar had previous welded repair. Original Post was repaired and reused.

- Removed Marker and Post
- Repaired Collar/ Post Fastening System
- Cleaned and Painted Marker as specified
- Re-set Post & Marker as specified

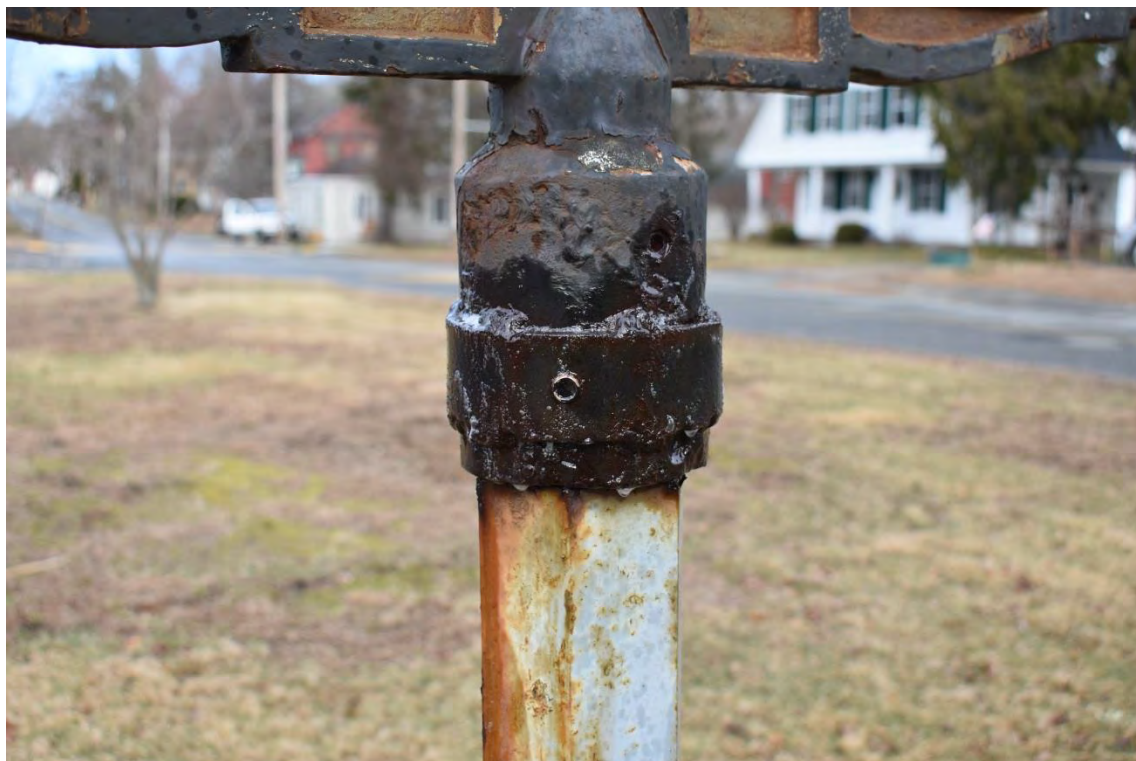
Indian Hill

Collar/Post
Intersection
Before & After

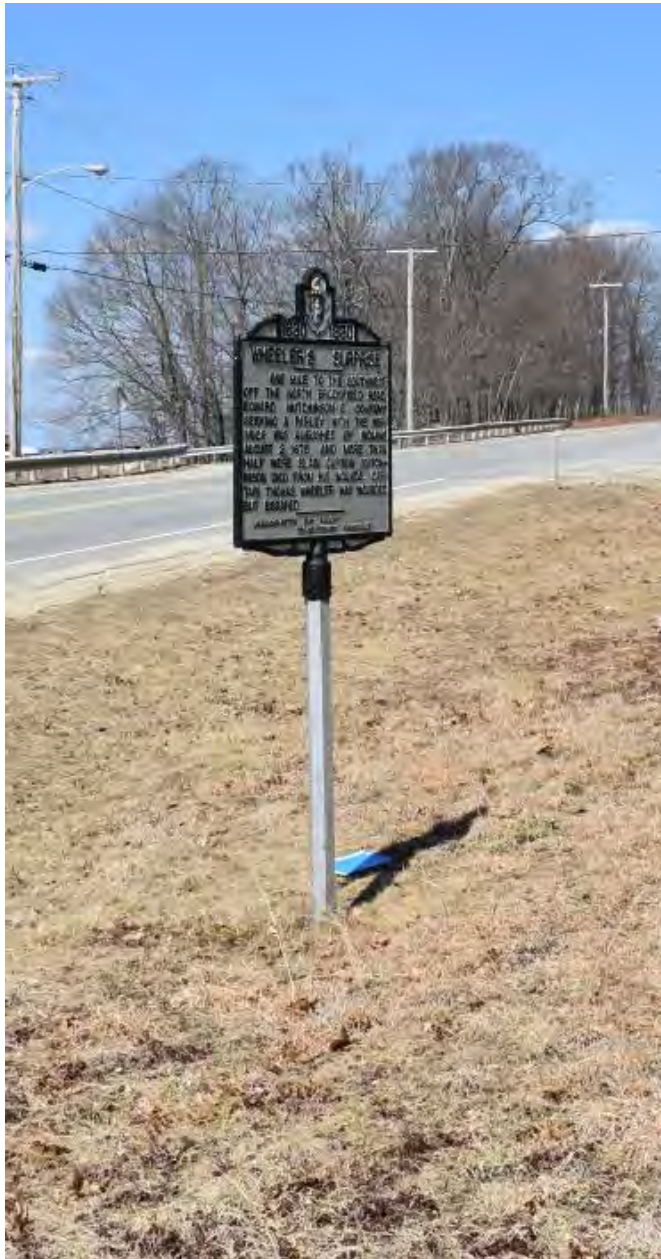
BEFORE TREATMENT

This marker is a replacement (or it was cast at different time): The marker is significantly heavier (thicker) than the original markers. The lettering is a different font and larger. The State Seal is lacking in definition and the scale of the elements is not correct. It appeared that the marker's had casting defects (drops and slag on the surface) which were not properly treated prior to the original installation. These defects were treated (chased) by Daedalus prior to painting

- Removed Marker and Post
- Repaired Collar/ Post Fastening System
- Cleaned and Painted Marker as specified
- Re-set Post & Marker as specified

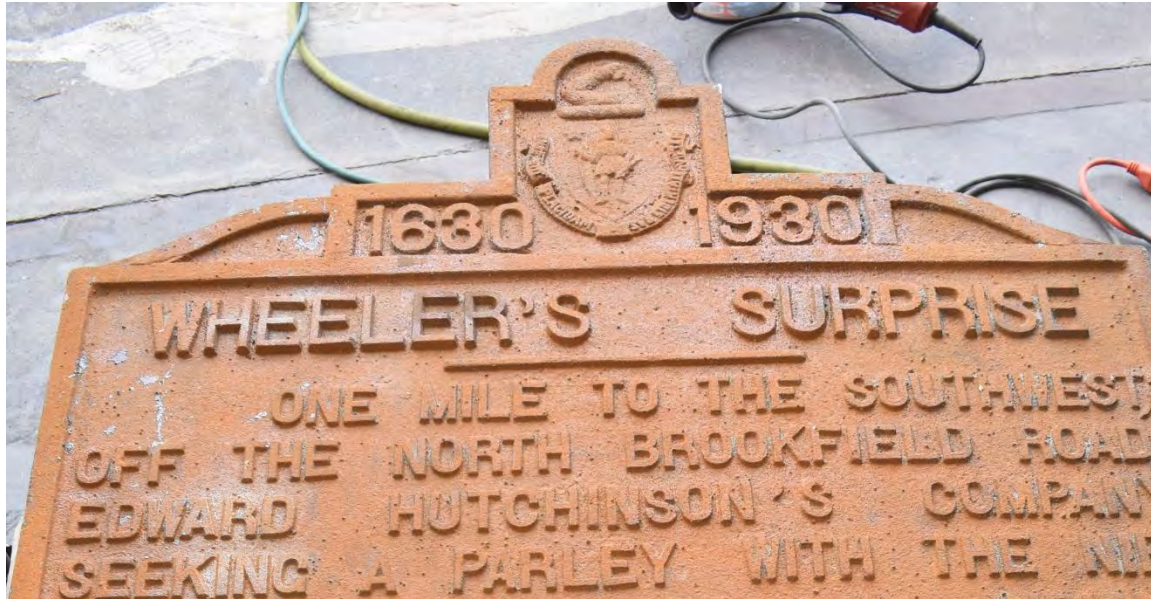
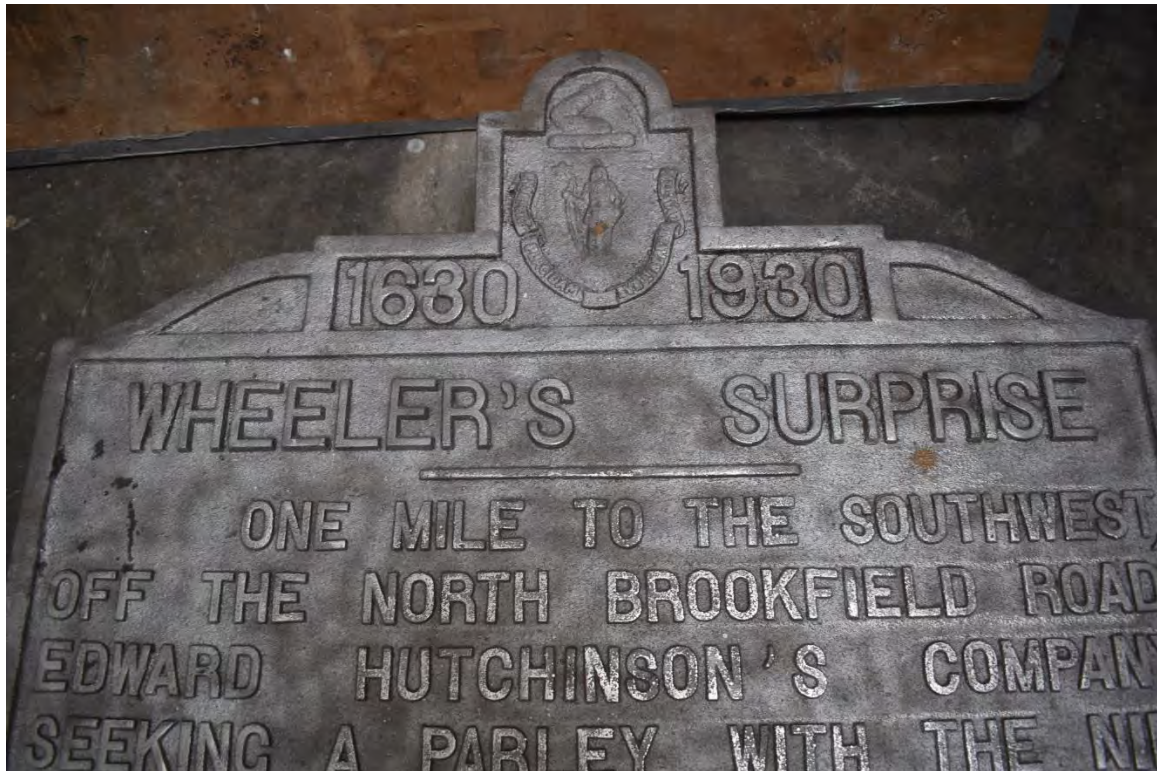
Before &
After Removal
of rust, drops
and slag
