RECORD OF TREATMENT

MASSACHUSETTS BAY COLONY TERCENTARY MARKERS

RECORD OF CONSERVATION TREATMENT

Objects: (11) Tercentenary Markers

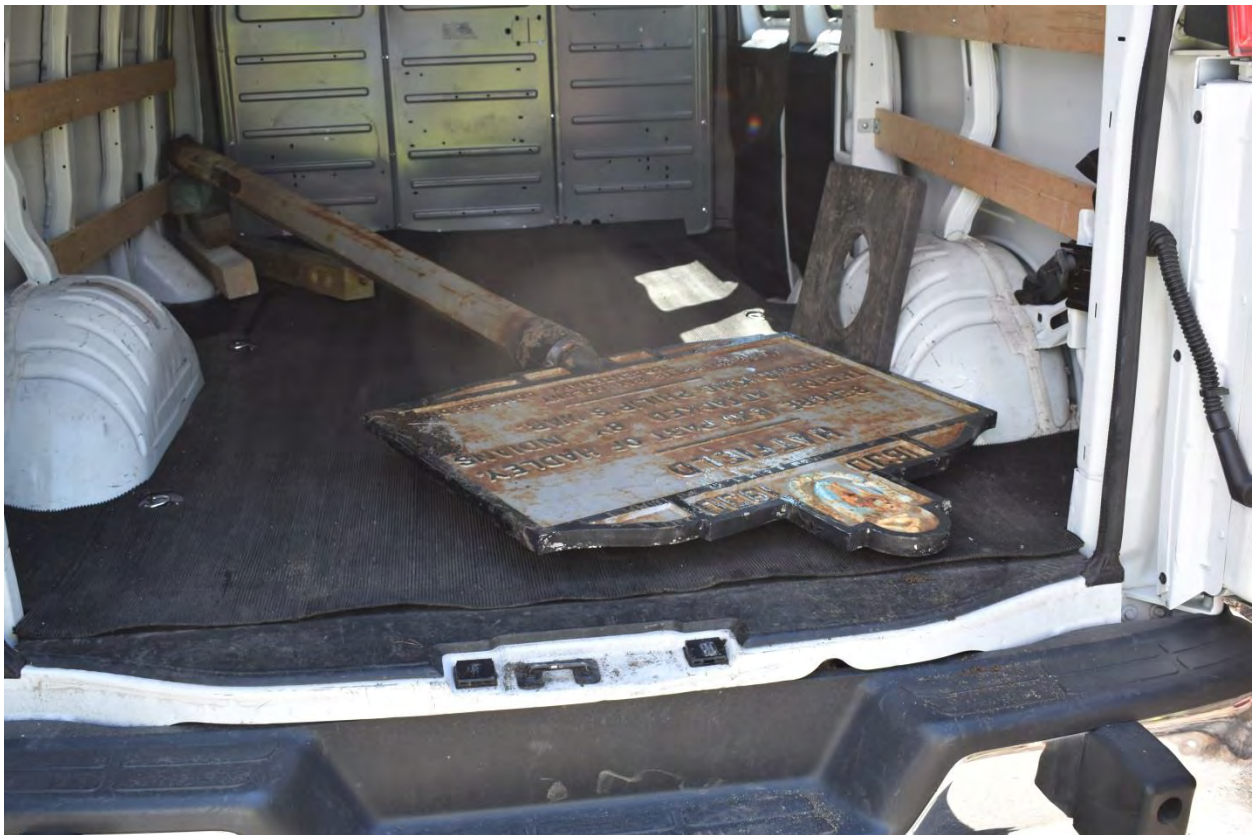
There were a couple of markers where the marker and post were welded together theses were brought to our studio intact and the welds were removed in a controlled setting,

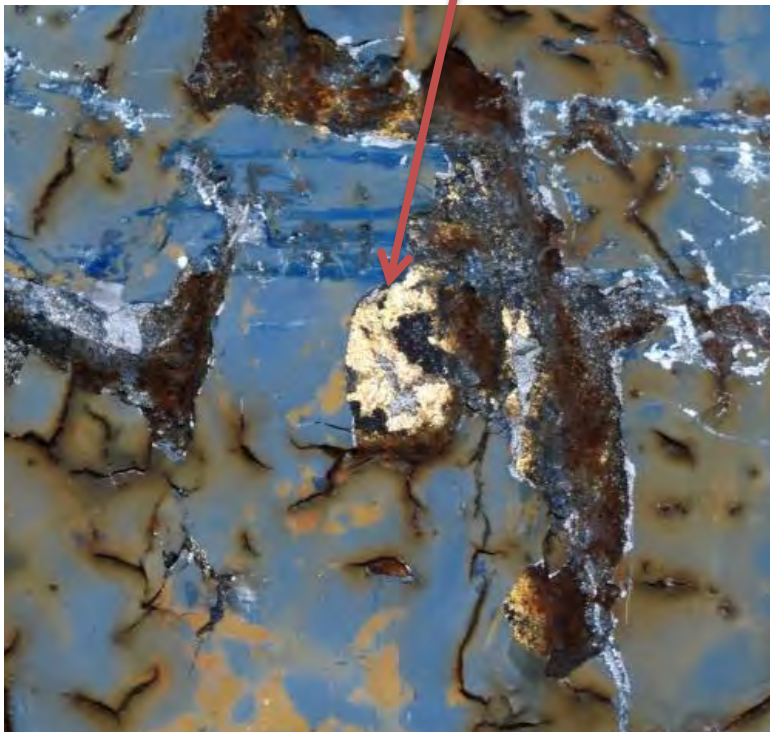
This appears to be
gold-leaf on the
surface below
layers of over-paint

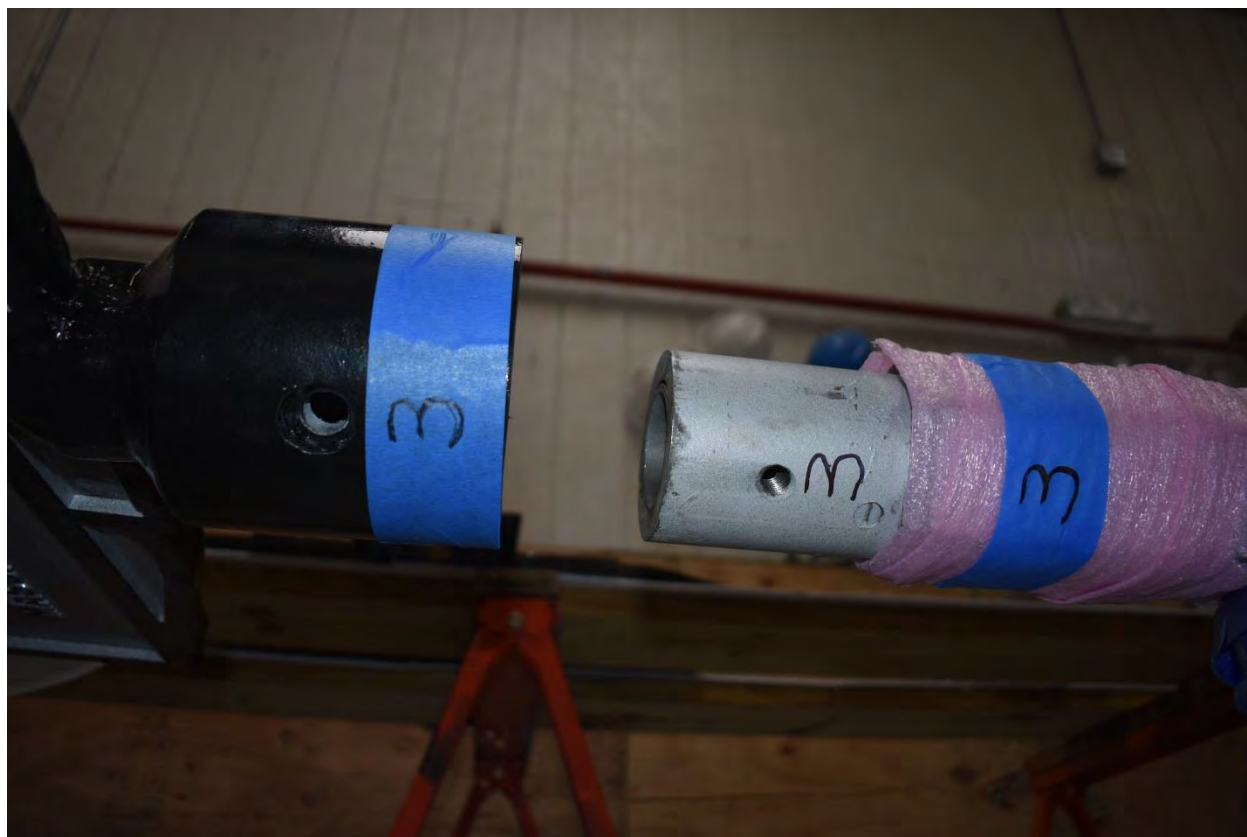
Collar to Post fastening system continued/ Holes only fit with corresponding number

The new fastening system has the original cast iron collars sandwiched between three sections of cold rolled steel secured both independently and as a whole with multiple 316 type stainless steel fasteners. The upward and lower facing edges are fully sealed with epoxy resin bulked with stainless steel powder and the surface is coated with durable exterior primer and paint system (see next section). This fastening system should help alleviate some of the stability issues observed in the original design.

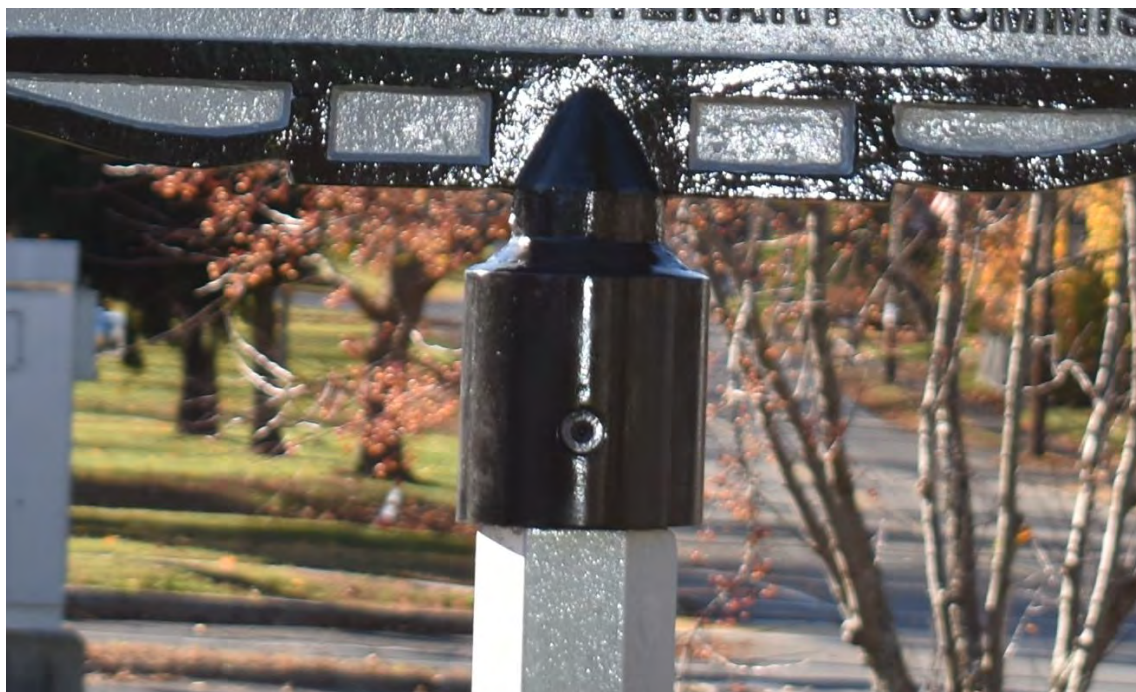
Indian Hill

Collar/Post
Intersection
Before & After

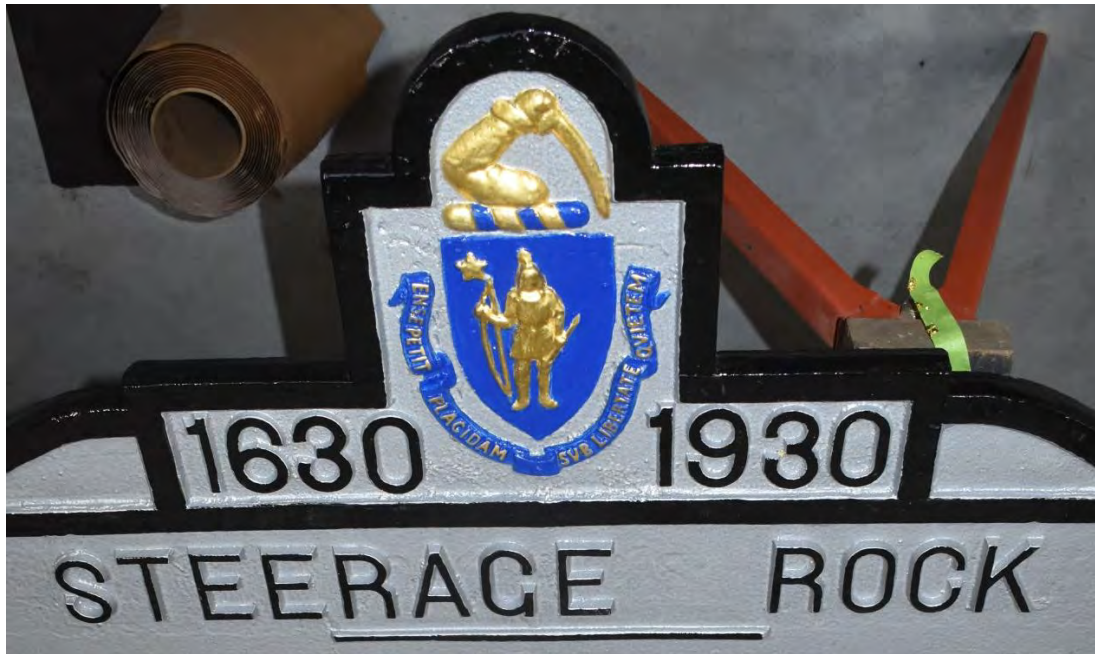
Detail: Differing
style of details
and font from
original casting

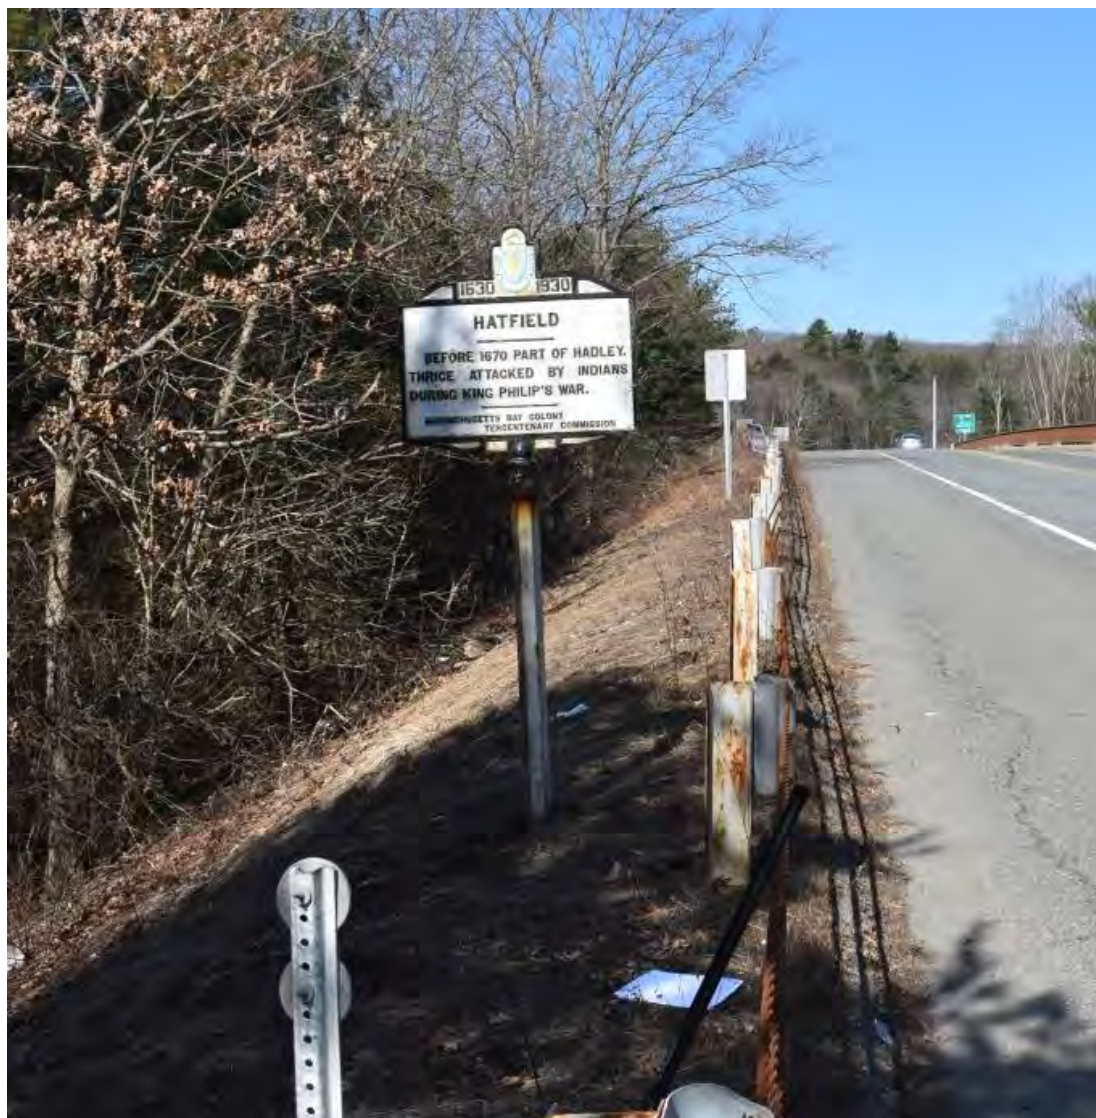
#4 Hatfield- Hatfield (#227)

Marker was
relocated

- Removed Marker and Post
- Repaired Collar/ Post Fastening System
- Cleaned and Painted Marker as specified
- Re-set Post & Marker as specified

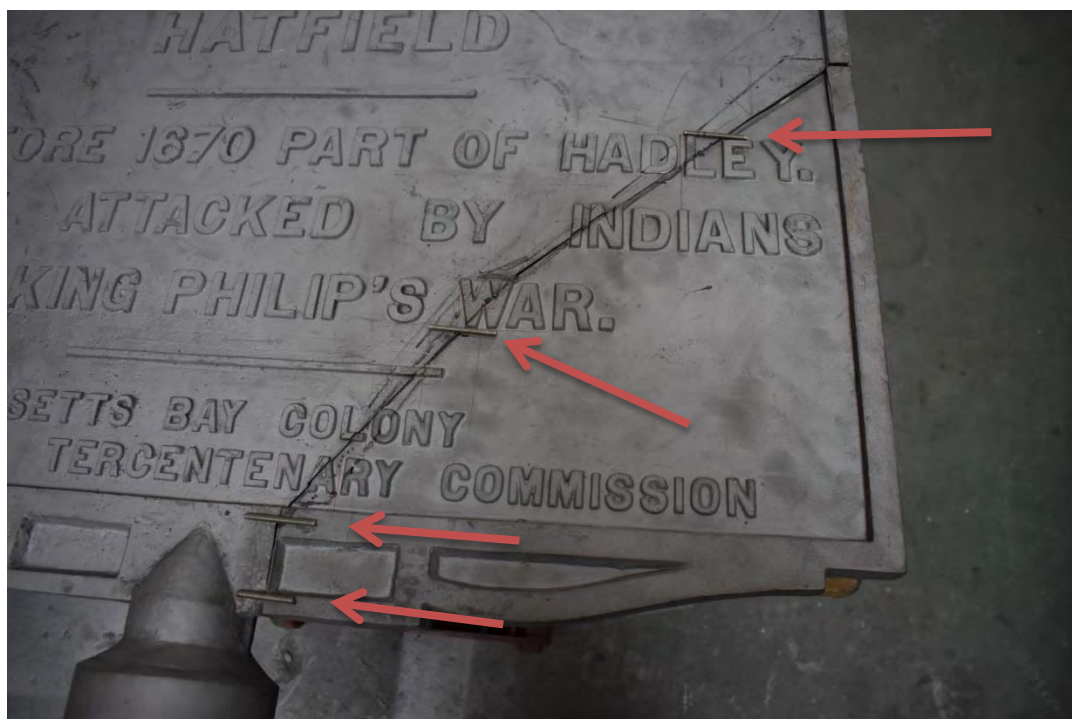
Mock-up of new
section and
location of blind
pins

Sections of DOM 1020 Steel (4-1/4" OD x 3.250" ID x .500" Wall) were cut to fill in the losses on the collar. These repaired sections were mechanically attached to the outer- collar prior to attaching the outer-collar to the post.

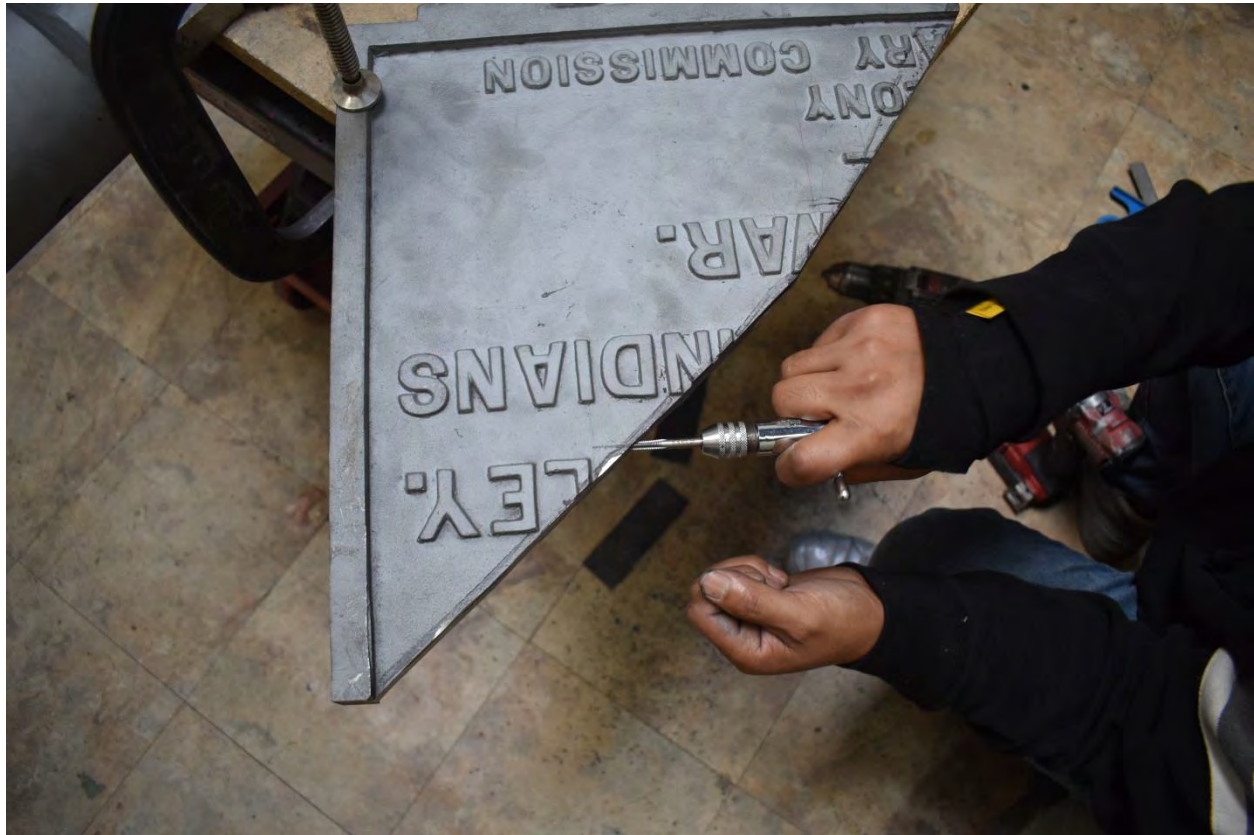
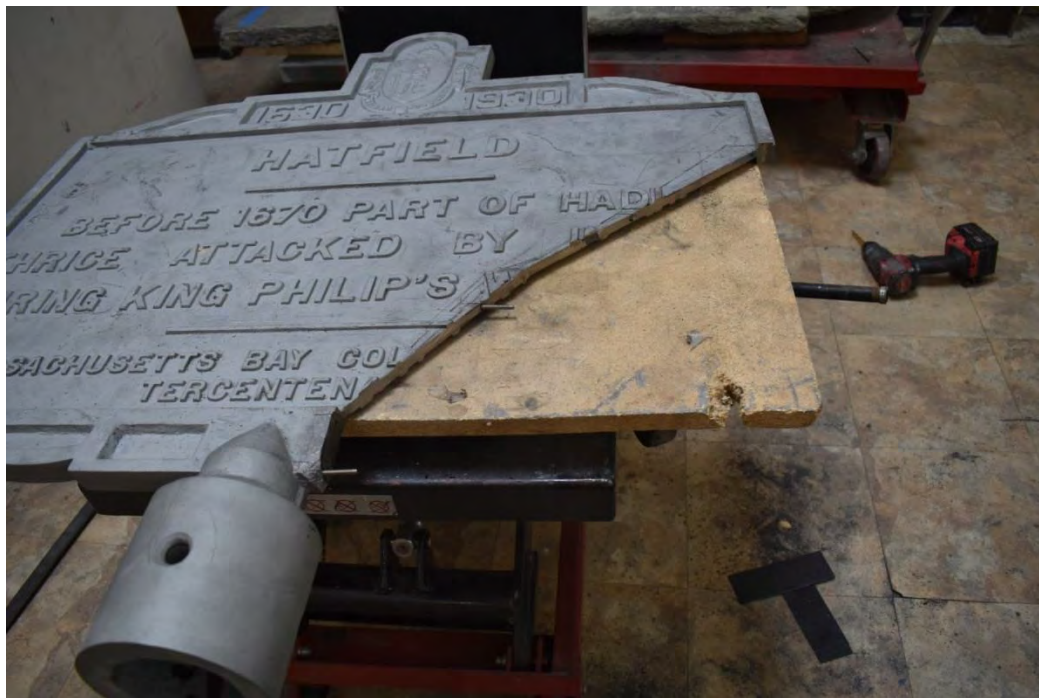
Tapping holes
for pins

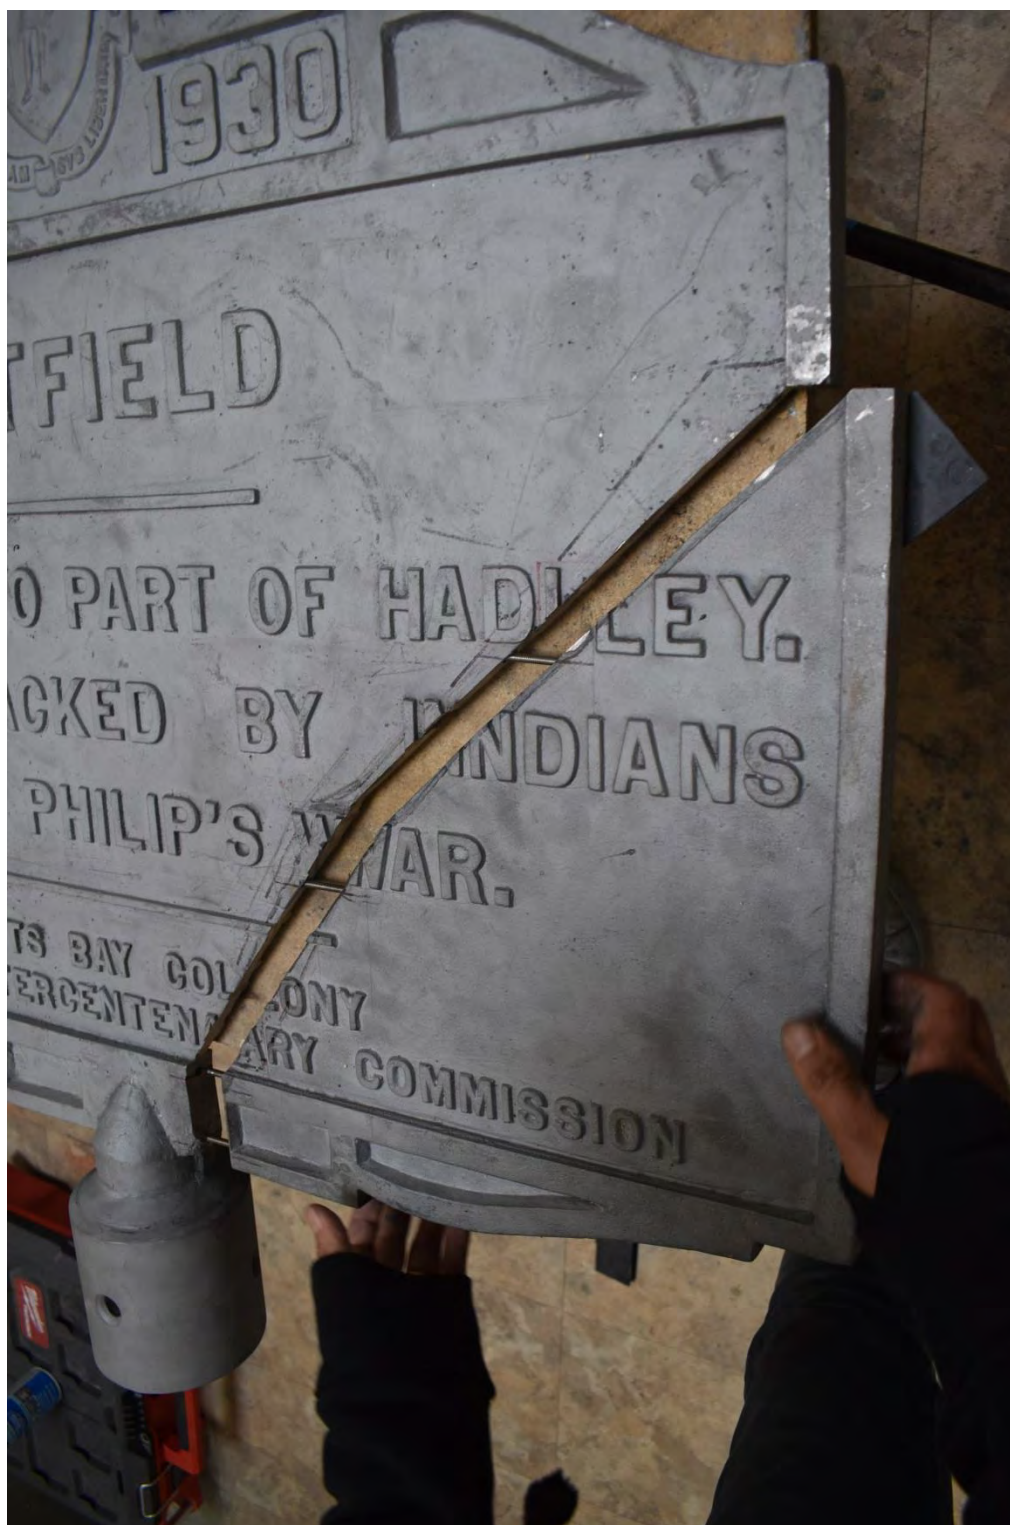
Mock-up with holes drilled and tapped

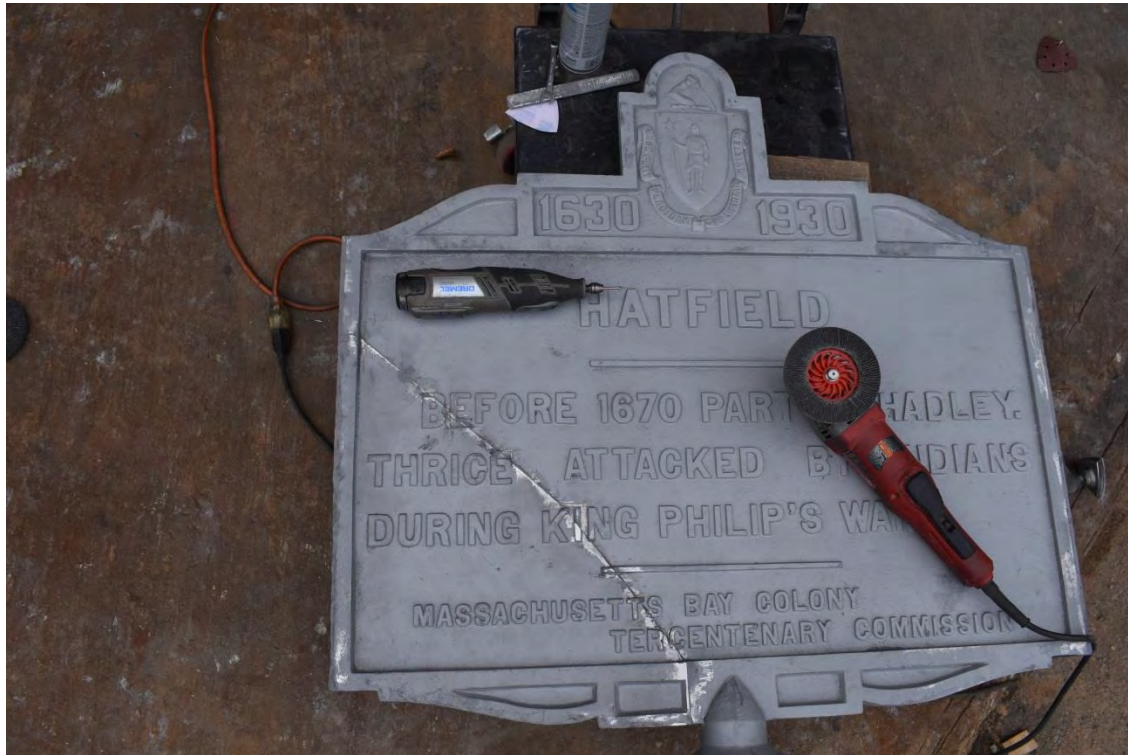
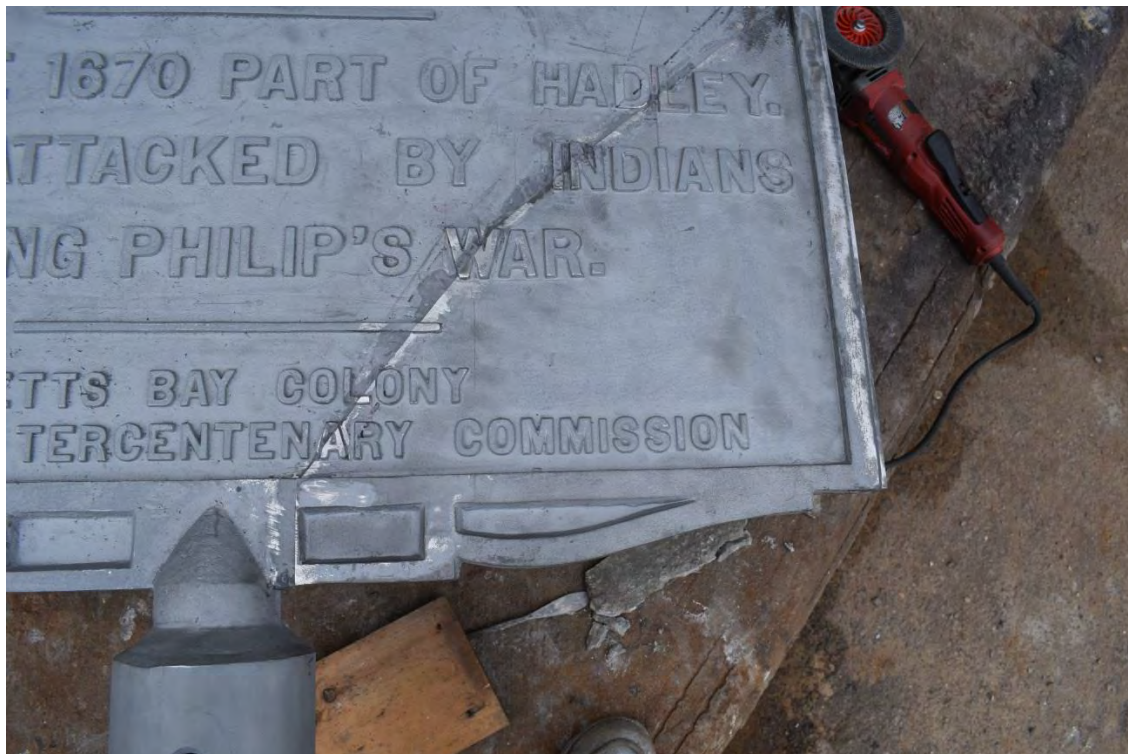
Final chasing,
after sections
were attached
with pins and
epoxy resin

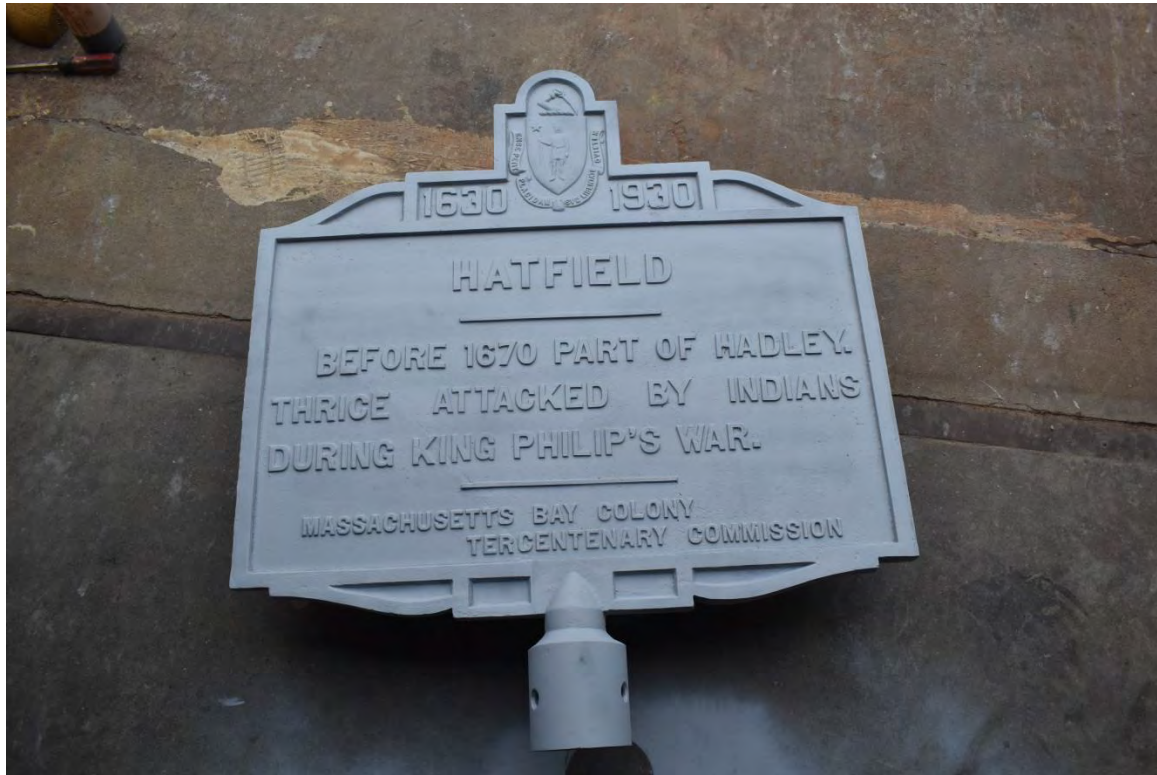
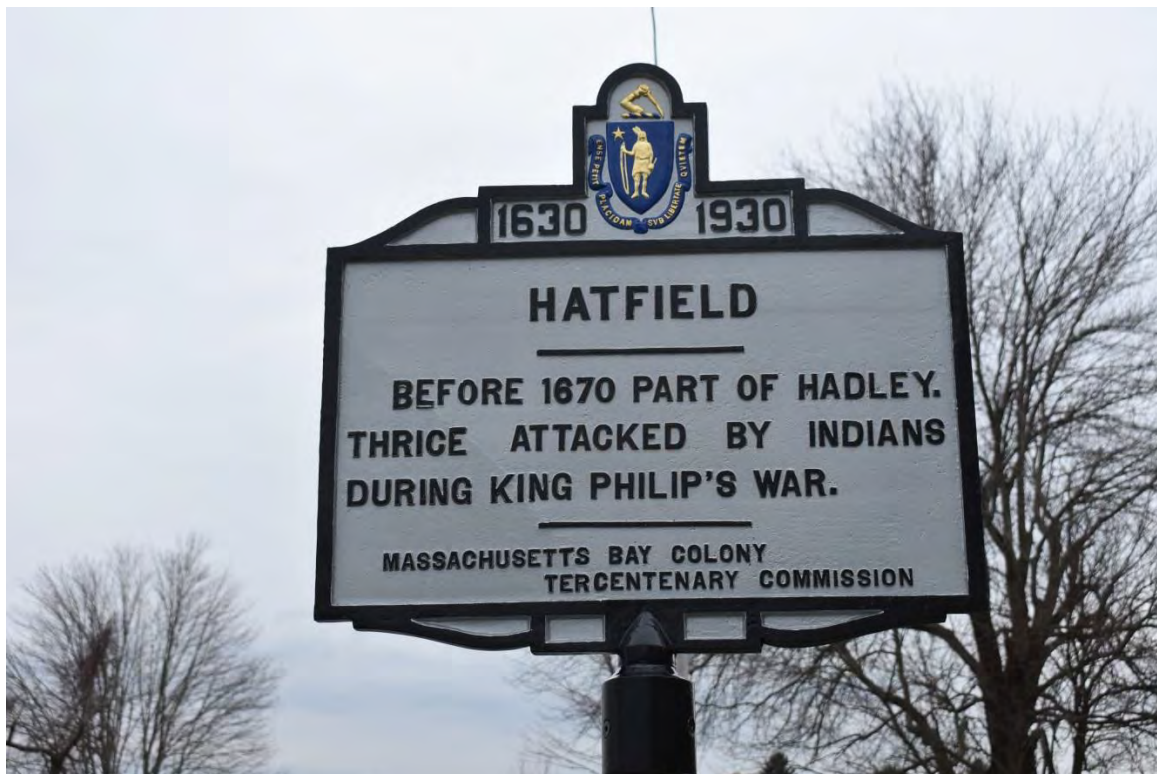
After being
primed &
After
completion of
paint and leaf.

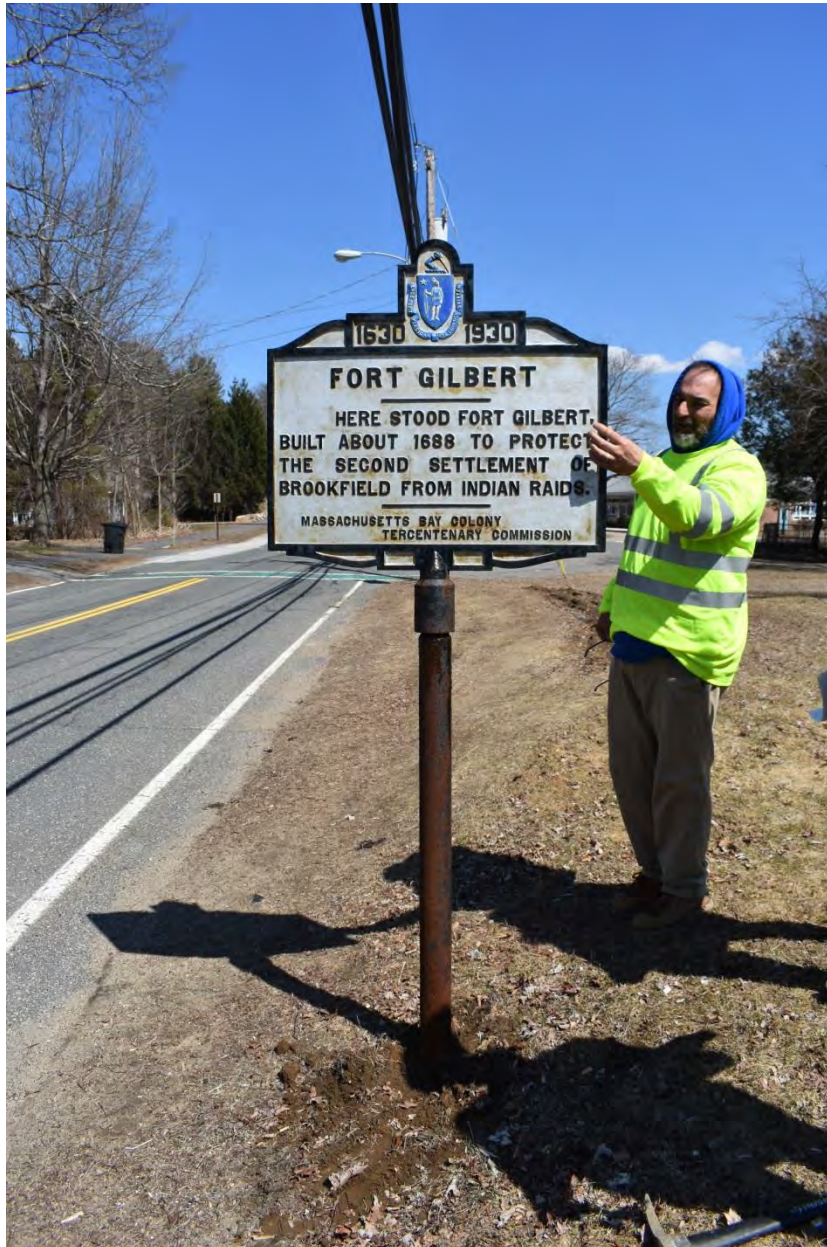
#6 West Brookfield- Fort Gilbert (#215)

BEFORE TREATMENT

- Removed Marker and Post
- Fabricated new Hexagonal Post
- Repaired Collar/ Post Fastening System
 - Cleaned and Painted Marker as specified
- Re-set Post & Marker as specified

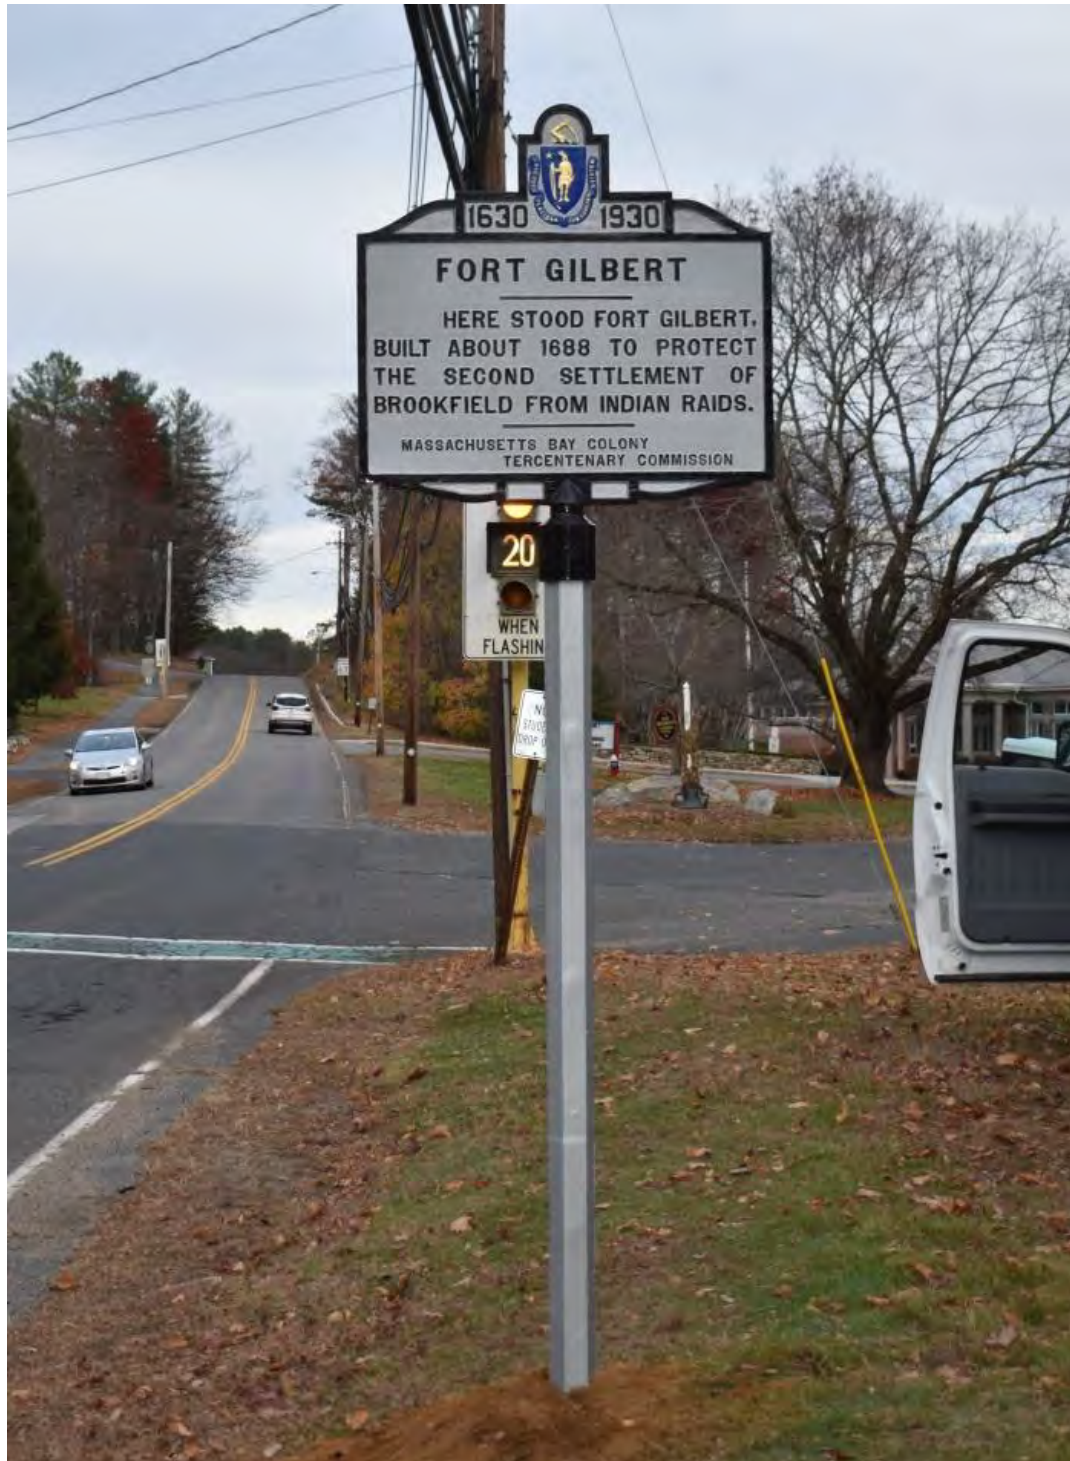
AFTER TREATMENT

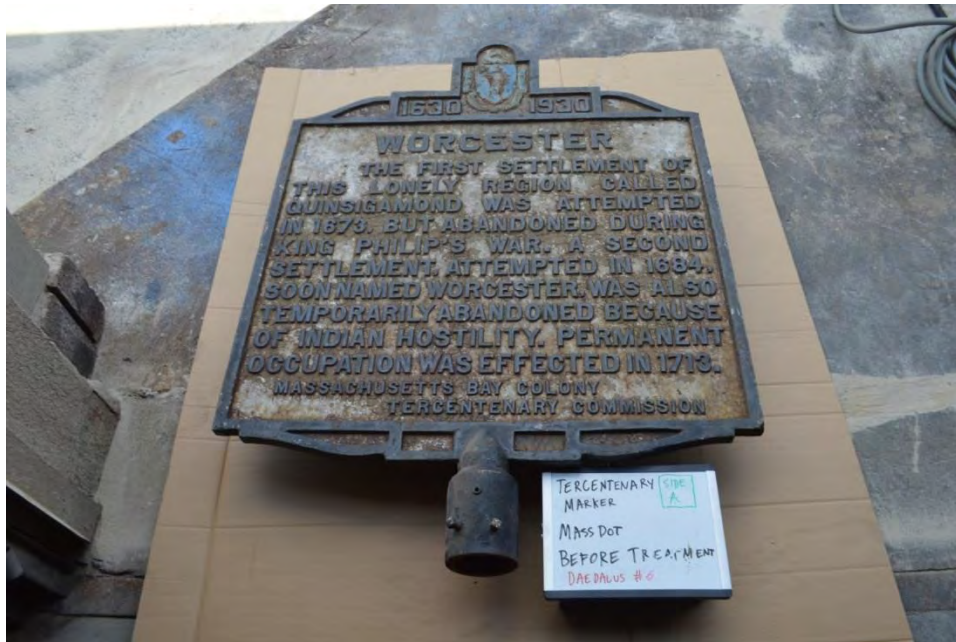
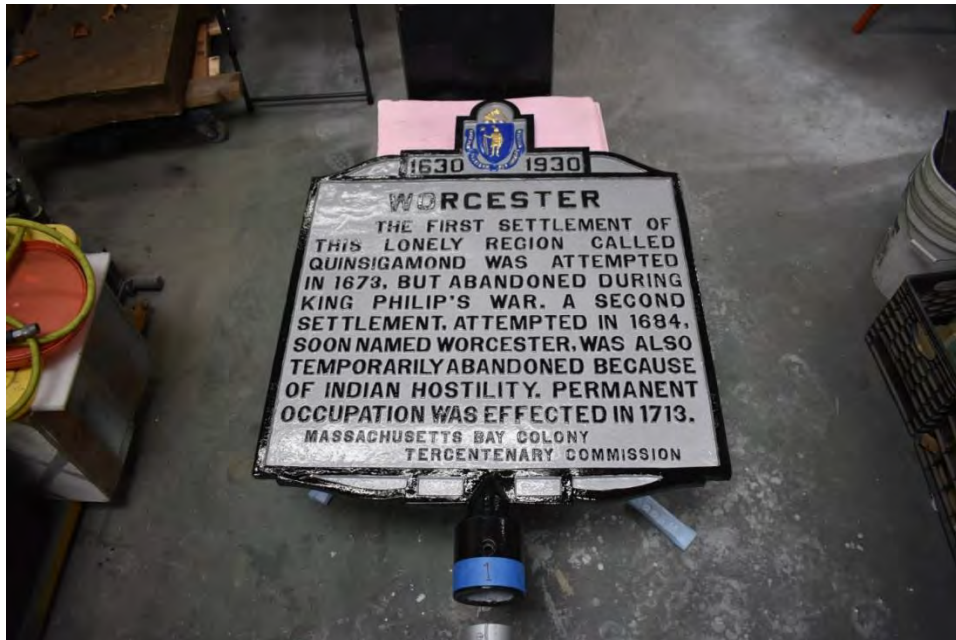
#7 Worcester- Worcester (#167)

BEFORE &
AFTER
TREATMENT

- Marker was retrieved from Mass Dot storage location
- Removed Marker and Post
- Fabricated new Hexagonal Post
- Repaired Collar/ Post Fastening System
- Cleaned and Painted Marker as specified
- Returned marker to Mass Dot for installation

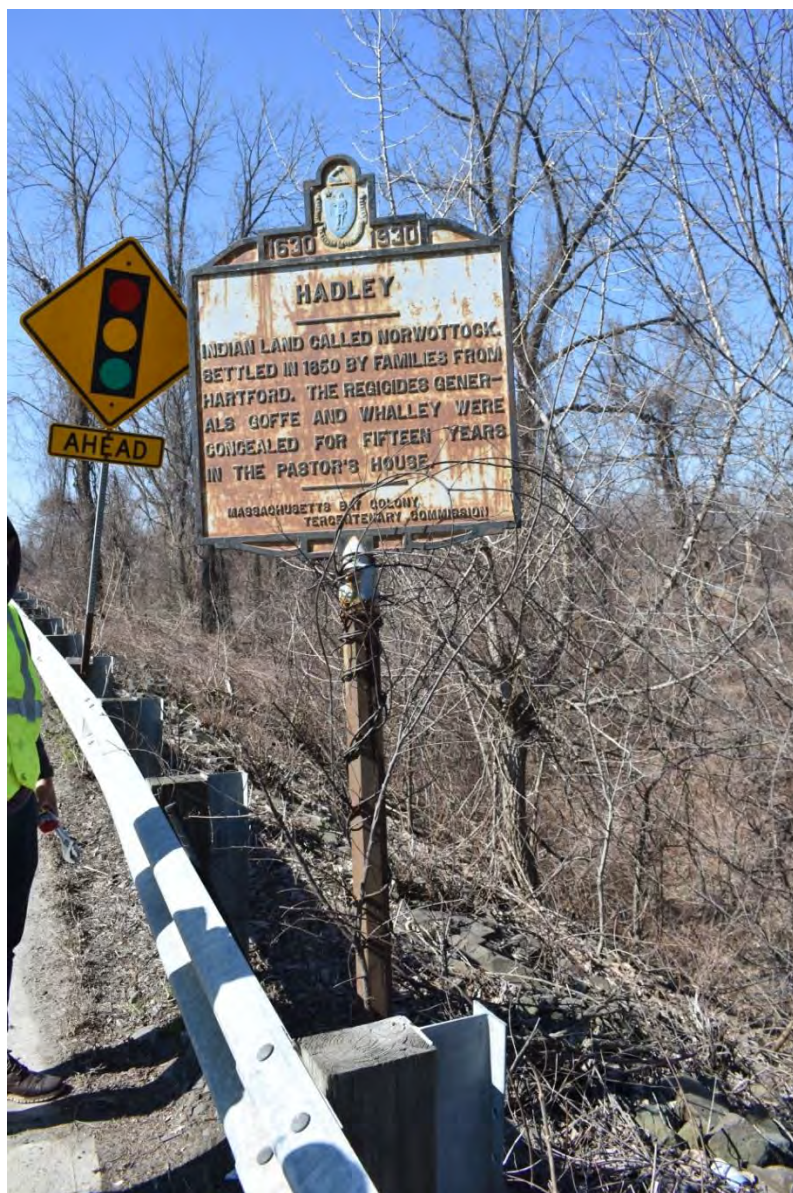
#8 Hadley – Hadley (#225)

Marker installed in new location

- Removed Marker and Post
- Fabricated new Hexagonal Post
- Repaired Collar/ Post Fastening System
- Cleaned and Painted Marker as specified
- Re-set Post & Marker as specified

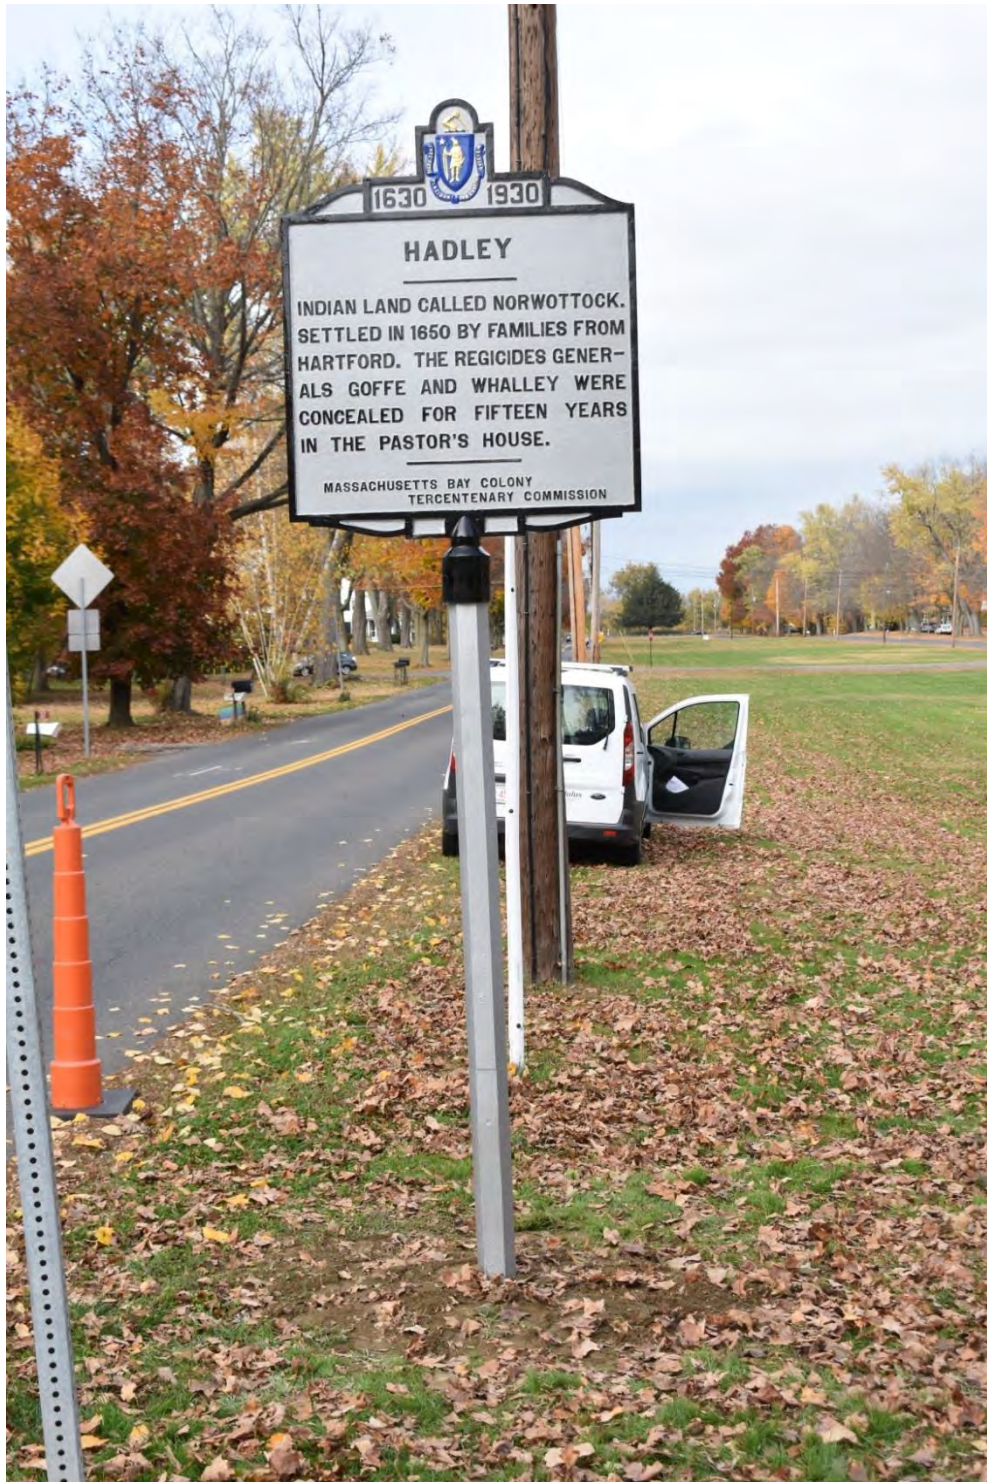
AFTER TREATMENT

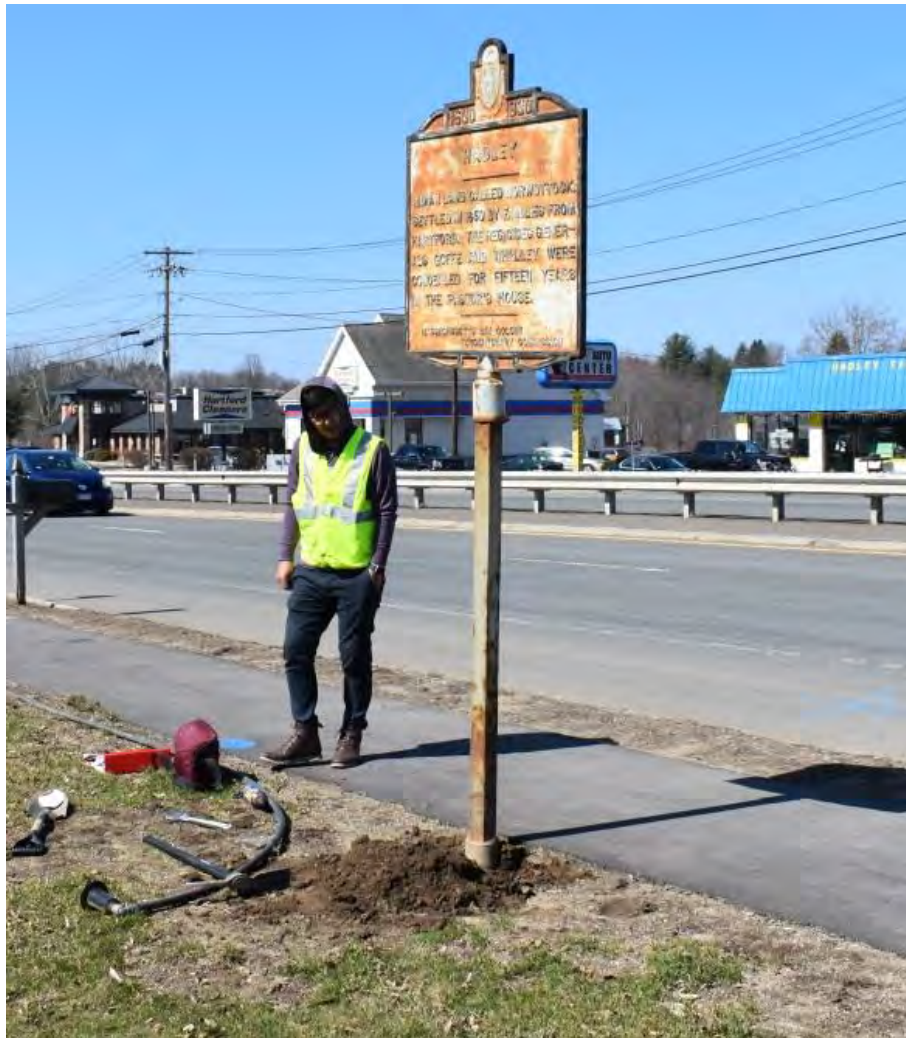
#9 Hadley – Hadley (#226)

Marker installed in new location

- Removed Marker and Post
- Fabricated new Hexagonal Post
- Repaired Collar/ Post Fastening System
- Cleaned and Painted Marker as specified
- Re-set Post & Marker as specified

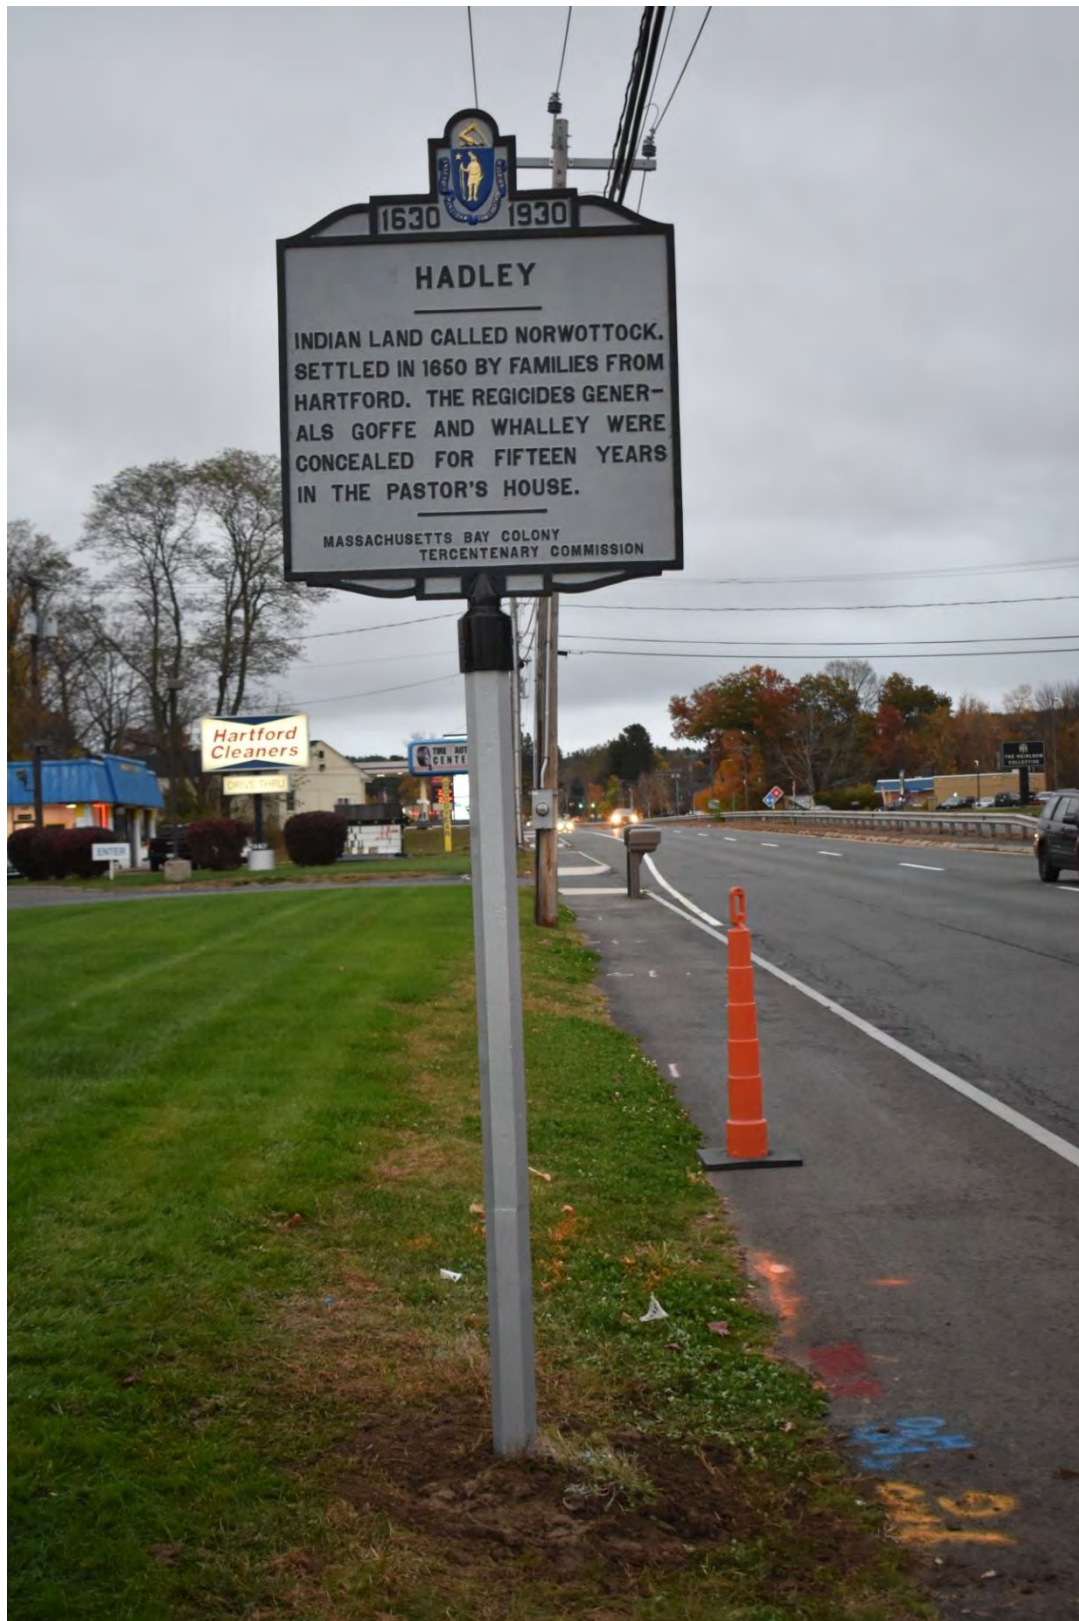
AFTER TREATMENT
