RECORD OF TREATMENT

MASSACHUSETTS BAY COLONY TERCENTARY MARKERS

RECORD OF CONSERVATION TREATMENT

Objects: (11) Tercentenary Markers

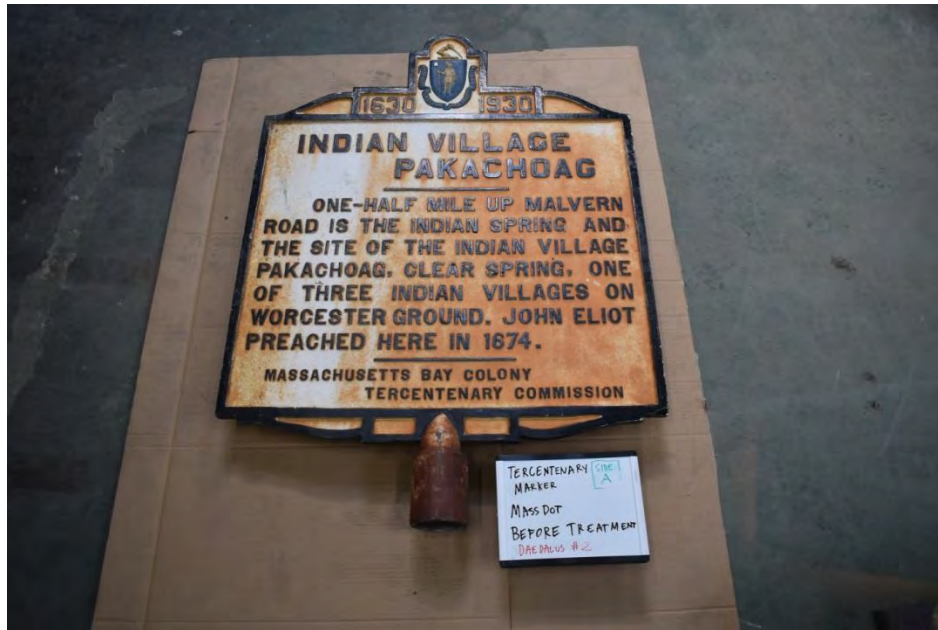
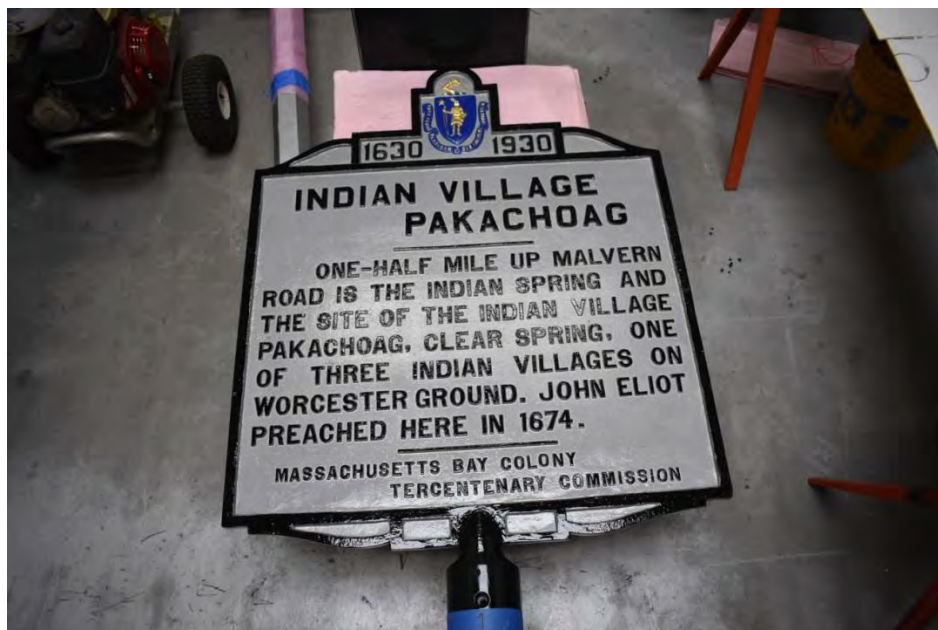
#10) Indian Village

BEFORE & AFTER
TREATMENT

- Marker was retrieved from Mass Dot storage location
- Removed Marker and Post
- Fabricated new Hexagonal Post
- Repaired Collar/ Post Fastening System
- Cleaned and Painted Marker as specified
- Returned marker to Mass Dot for installation

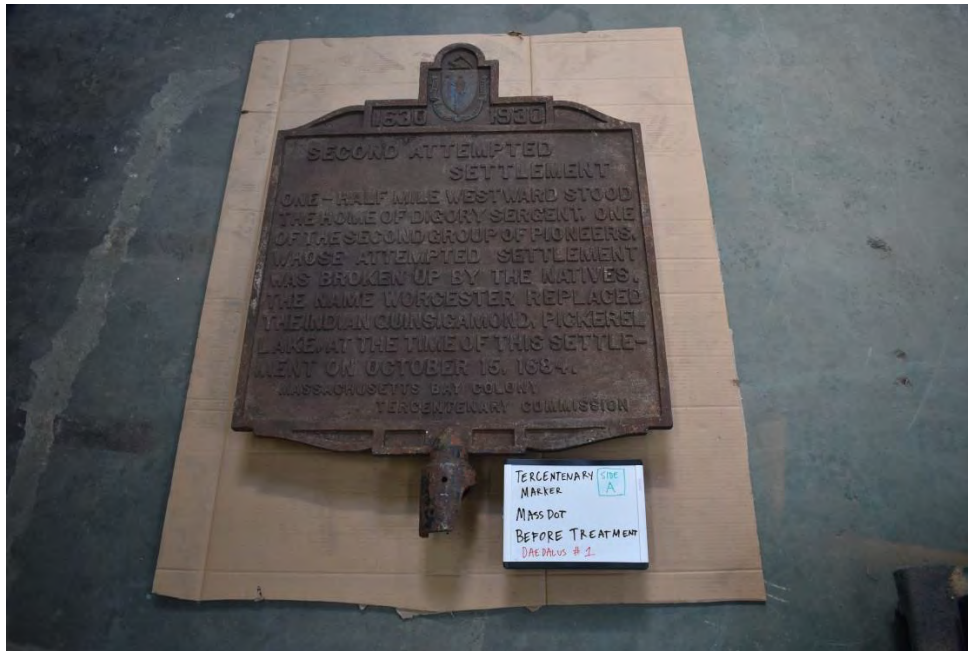
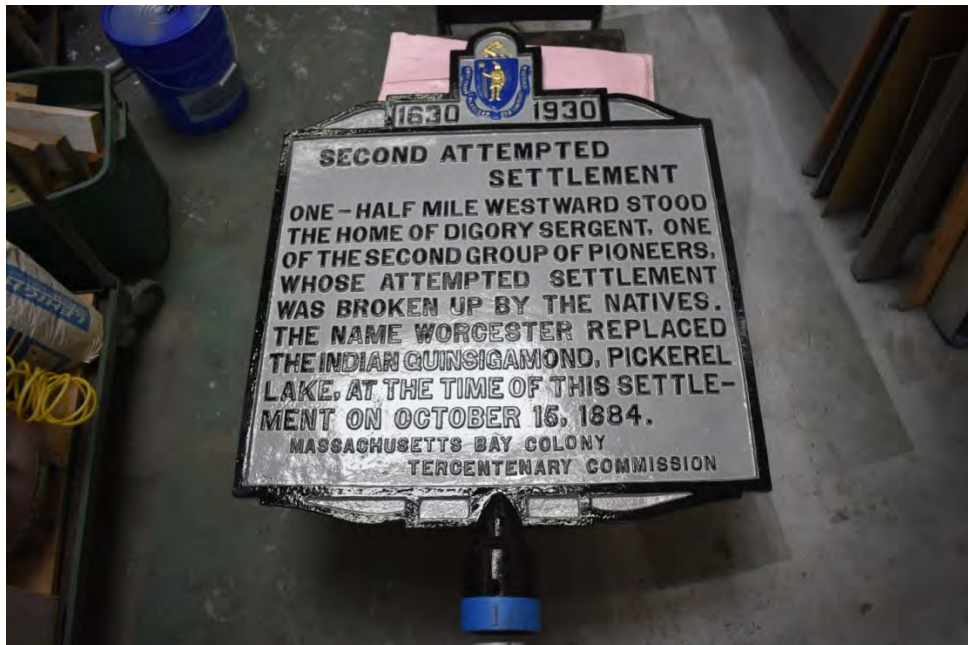
#11) Second Attempted Settlement

BEFORE & AFTER
TREATMENT

- Marker was retrieved from Mass Dot storage location
- Removed Marker and Post
- Fabricated new Hexagonal Post
- Repaired Collar/ Post Fastening System
- Cleaned and Painted Marker as specified
- Returned marker to Mass Dot for installation
